Contract #: 04-0120F4Cty: SF/ALA Rte: 80 PM: 13.2/13.9File #: 69.28**WELDING INSPECTION REPORT****Resident Engineer:** Siegenthaler, Peter**Address:** 333 Burma Road**City:** Oakland, CA 94607**Report No:** WIR-019065**Date Inspected:** 28-Dec-2010**Project Name:** SAS Superstructure**OSM Arrival Time:** 700**Prime Contractor:** American Bridge/Fluor Enterprises, a JV**OSM Departure Time:** 1900**Contractor:** Zhenhua Port Machinery Company, Ltd (ZPMC), Changxing Island **Location:** Shanghai, China

Bridge No: 34-0006**Component:** Orthotropic Box Girder (OBG)**Summary of Items Observed:**

BAY- 7-Cross beam (CB)-CB19 (Segment tagging).

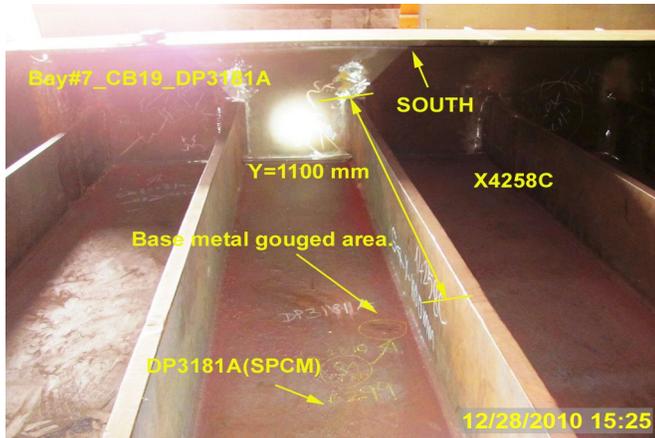
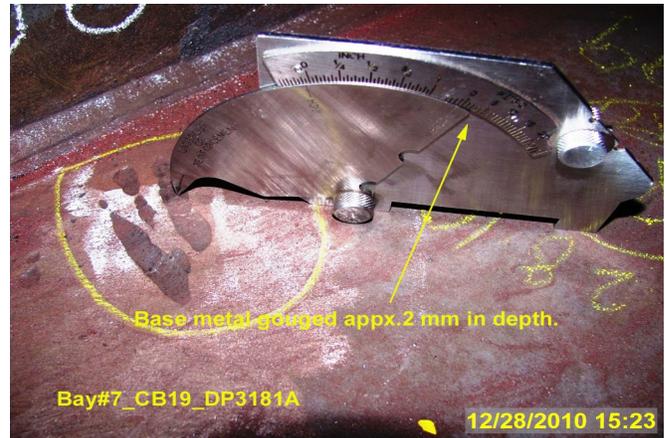
During random Visual Testing of OBG CB19 deck plate, this QA observed base metal gouged on Piece Mark (PCMK) identified as DP3181A. The “Y” location is approximately 1100 mm from south side cope hole. This QA marked the affected area and measured the depth approximately 2mm and informed ZPMC Quality Control (QC) Certified Welding Inspector indentified as Mr. Huang min of this issue. Mr. Huang min informed this QA that the gouged area would be corrected in a manner compliant with the contract documents. Refer the attached photos for reference.
