**DEPARTMENT OF TRANSPORTATION**

Contract #: 04-0120F4Cty: SF/ALA Rte: 80 PM: 13.2/13.9File #: 99.28**WELDING INSPECTION REPORT****Resident Engineer:** Siegenthaler, Peter**Address:** 333 Burma Road**City:** Oakland, CA 94607**Report No:** WIR-019073**Date Inspected:** 09-Jan-2011**Project Name:** SAS Superstructure**OSM Arrival Time:** 700**Prime Contractor:** American Bridge/Fluor Enterprises, a JV**OSM Departure Time:** 1900**Contractor:** Zhenhua Port Machinery Company, Ltd (ZPMC) Chanxing Island**Location:** Shanghai, China

## WELDING INSPECTION REPORT

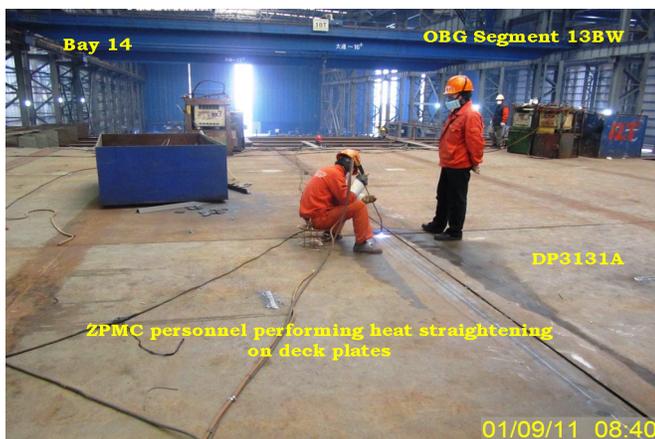
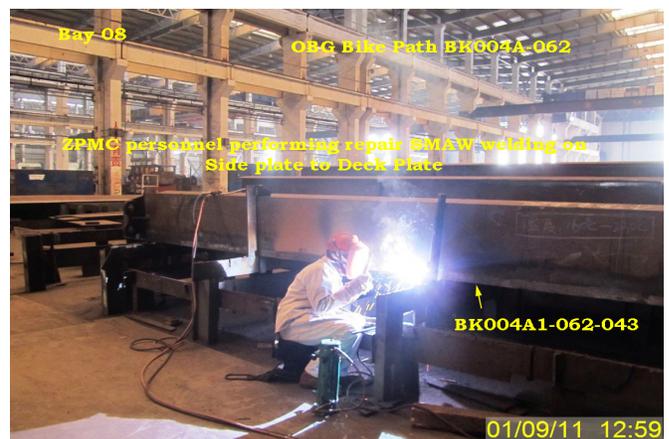
ZPMC personnel performing heat straightening on deck plate of OBG Segment 13BW member identified as DP3130A, DP3131A and DP3132A. Distortion appeared to be caused by mishandling of the welding/material. ZPMC Quality Control (QC) inspector identified as Mr. Li Ming Yang was present to monitor the heat straightening process. The heat straightening appeared to comply with HSR1 (B) number 10040. See the attached picture.
