Contract #: 04-0120F4Cty: SF/ALA Rte: 80 PM: 13.2/13.9File #: 99.28**WELDING INSPECTION REPORT****Resident Engineer:** Siegenthaler, Peter**Address:** 333 Burma Road**City:** Oakland, CA 94607**Report No:** WIR-019075**Date Inspected:** 31-Dec-2010**Project Name:** SAS Superstructure**OSM Arrival Time:** 700**Prime Contractor:** American Bridge/Fluor Enterprises, a JV**OSM Departure Time:** 1900**Contractor:** Zhenhua Port Machinery Company, Ltd (ZPMC) Chanxing Island**Location:** Shanghai, China

Bridge No: 34-0006**Component:** OBG Segment**Summary of Items Observed:**

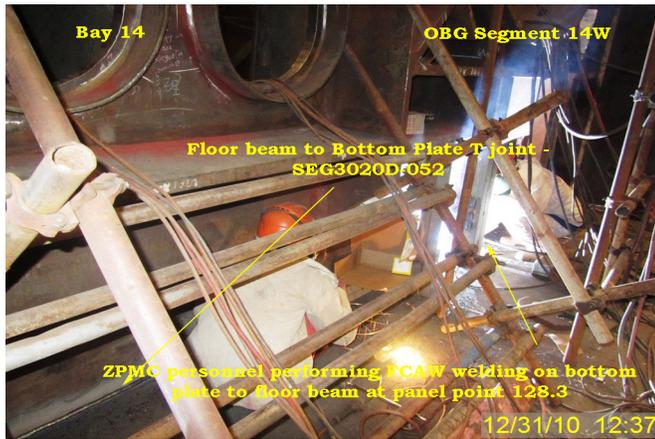
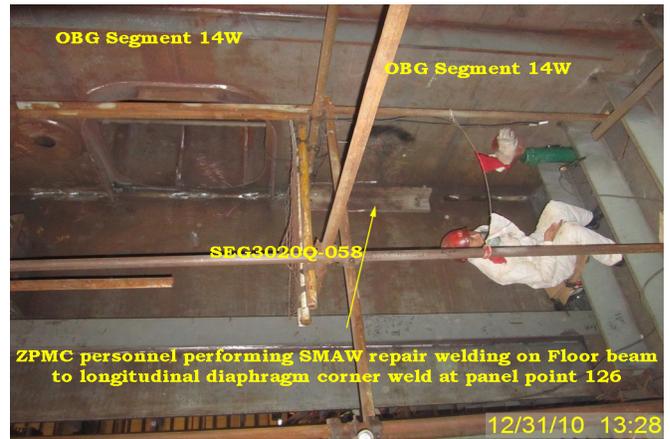
Description of Incident: During the Quality Assurance random visual inspection of welds located on Segment 14W, this Quality Assurance Inspector (QA) observed ZMPC personnel performing gouging on Floor beam to longitudinal diaphragm corner weld, because of ZMPC UT repair. Over all inspection of this weld, more than 50% weld lengths are defect marked by ZMPC personnel. The weld is identified as SEG3020Q-058. This weld is a Complete Joint Penetration (CJP) weld joining the Floor Beam to Longitudinal Diaphragm. The Floor Beam to Longitudinal Diaphragm weld is identified as SPCM. This weld is designated as Seismic Performance Critical Member (SPCM). OBG segment 14W is located West Side of Bay 14 area. The ZPMC QC is identified as Mr. Li Ming Yang. QA inform to ZPMC that prior to the repair welding, to prepare CWR and ensure with VT and MT all defect have been removed. See the attaché picture.
