Contract #: 04-0120F4Cty: SF/ALA Rte: 80 PM: 13.2/13.9File #: 99.28**WELDING INSPECTION REPORT****Resident Engineer:** Siegenthaler, Peter**Address:** 333 Burma Road**City:** Oakland, CA 94607**Report No:** WIR-019084**Date Inspected:** 20-Dec-2010**Project Name:** SAS Superstructure**OSM Arrival Time:** 700**Prime Contractor:** American Bridge/Fluor Enterprises, a JV**OSM Departure Time:** 1900**Contractor:** Zhenhua Port Machinery Company, Ltd (ZPMC) Chanxing Island**Location:** Shanghai, China**CWI Name:** Mr. Geng Wei**CWI Present:** Yes No**Inspected CWI report:** Yes No N/A**Rod Oven in Use:** Yes No N/A**Electrode to specification:** Yes No N/A**Weld Procedures Followed:** Yes No N/A**Qualified Welders:** Yes No N/A**Verified Joint Fit-up:** Yes No N/A**Approved Drawings:** Yes No N/A**Approved WPS:** Yes No N/A**Delayed / Cancelled:** Yes No N/A**Bridge No:** 34-0006**Component:** OBG Bike Path**Summary of Items Observed:**

WELDING INSPECTION REPORT

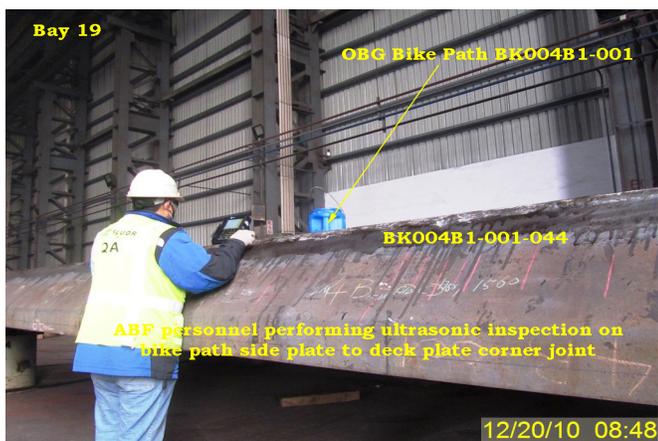
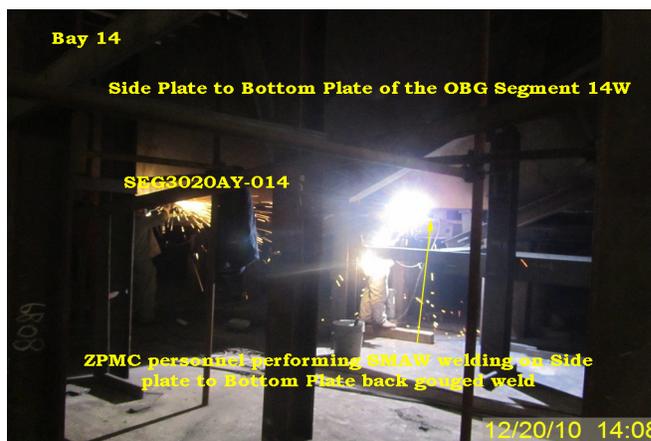
This QA inspector observed that ABF personnel performed Ultrasonic Testing on deck plate to side plate of OBG Bike Path BK004B1-001 and the weld joint is identified as BK004B1-001-044. See the attached picture.
