Quality Assurance and Source Inspection

Contract #: 04-0120F4Cty: SF/ALA Rte: 80 PM: 13.2/13.9File #: 69.28**WELDING INSPECTION REPORT****Resident Engineer:** Siegenthaler, Peter**Address:** 333 Burma Road**City:** Oakland, CA 94607**Report No:** WIR-019109**Date Inspected:** 03-Jan-2011**Project Name:** SAS Superstructure**OSM Arrival Time:** 700**Prime Contractor:** American Bridge/Fluor Enterprises, a JV**OSM Departure Time:** 1900**Contractor:** Zhenhua Port Machinery Company, Ltd (ZPMC), Changxing Island **Location:** Shanghai, China**CWI Name:** Xu tao**CWI Present:** Yes No**Inspected CWI report:** Yes No N/A**Rod Oven in Use:** Yes No N/A**Electrode to specification:** Yes No N/A**Weld Procedures Followed:** Yes No N/A**Qualified Welders:** Yes No N/A**Verified Joint Fit-up:** Yes No N/A**Approved Drawings:** Yes No N/A**Approved WPS:** Yes No N/A**Delayed / Cancelled:** Yes No N/A**Bridge No:** 34-0006**Component:** OBG Components**Summary of Items Observed:**

WELDING INSPECTION REPORT

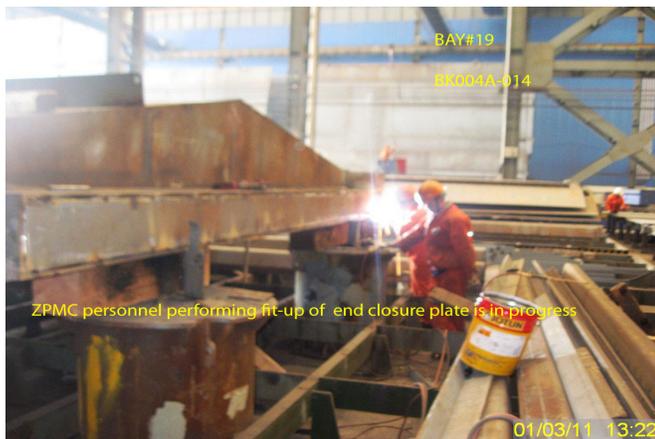
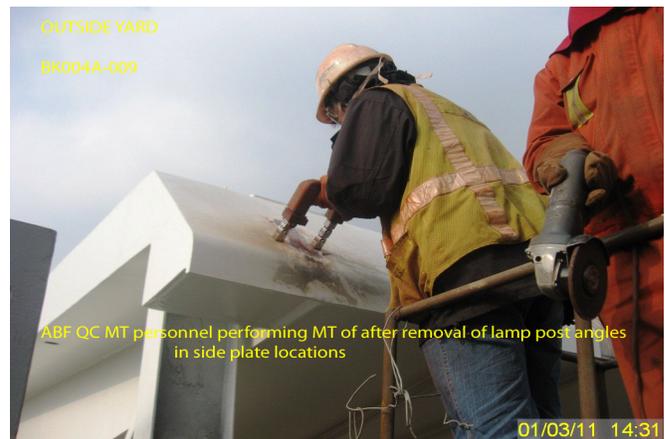
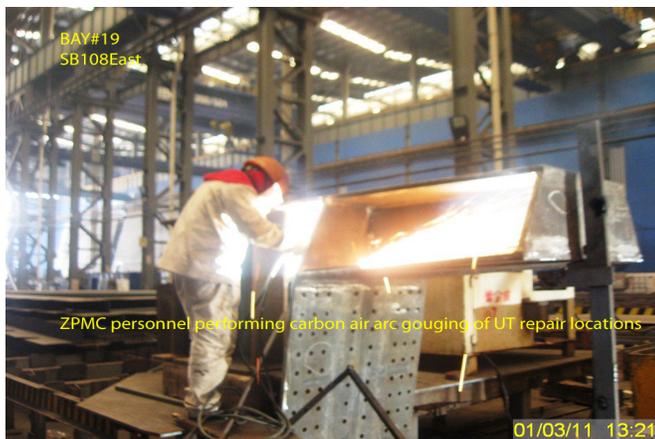
SMAW welding of repair (R2) weld is identified as 3G-013 of SB023-106 for SB106 East. The welder is identified as 037996. ZPMC QC is identified as Mr. Guo xing hui. The welding variables recorded by QC are appeared to comply with the WPS-345-SMAW-3G-Repair and WR19298.

SMAW welding of repair (R2) weld is identified as 3G-015 of SB022-106 for SB106 West. The welder is identified as 066002. ZPMC QC is identified as Mr. Guo xing hui. The welding variables recorded by QC are appeared to comply with the WPS-345-SMAW-3G-Repair and R19246.

FCAW welding of weld is identified as 2G-007 of BK004A6-014 for BK004A-014. The welder is identified as 062757. ZPMC QC is identified as Mr. Xu tao. The welding variables recorded by QC are appeared to comply with the WPS-B-T-2232-ESAB.

Trail assembly of bike path BK004A-006 and BK004 A-007 is in progress.

ABF QC NDT MT personnel performing MT after light bracket removal locations of bike path BK004A-009,008, 005 is in progress.

ZPMC QC personnel checking the dimension of anchor houses Slot hole is in progress of following bike paths BK004A-002,005,007,008,012.

Visual inspection of welds and internal cleanings carryout before fit-up of end closure plate with bike path of BK004A-013.
