DEPARTMENT OF TRANSPORTATION

Quality Assurance and Source Inspection

Contract #: 04-0120F4Cty: SF/ALA Rte: 80 PM: 13.2/13.9File #: 69.28**WELDING INSPECTION REPORT****Resident Engineer:** Siegenthaler, Peter**Address:** 333 Burma Road**City:** Oakland, CA 94607**Report No:** WIR-019146**Date Inspected:** 01-Jan-2011**Project Name:** SAS Superstructure**OSM Arrival Time:** 700**Prime Contractor:** American Bridge/Fluor Enterprises, a JV**OSM Departure Time:** 1900**Contractor:** Zhenhua Port Machinery Company, Ltd (ZPMC), Changxing Island **Location:** Shanghai, China**CWI Name:** Lv Li Qing**CWI Present:** Yes No**Inspected CWI report:** Yes No N/A**Rod Oven in Use:** Yes No N/A**Electrode to specification:** Yes No N/A**Weld Procedures Followed:** Yes No N/A**Qualified Welders:** Yes No N/A**Verified Joint Fit-up:** Yes No N/A**Approved Drawings:** Yes No N/A**Approved WPS:** Yes No N/A**Delayed / Cancelled:** Yes No N/A**Bridge No:** 34-0006**Component:** OBG**Summary of Items Observed:**

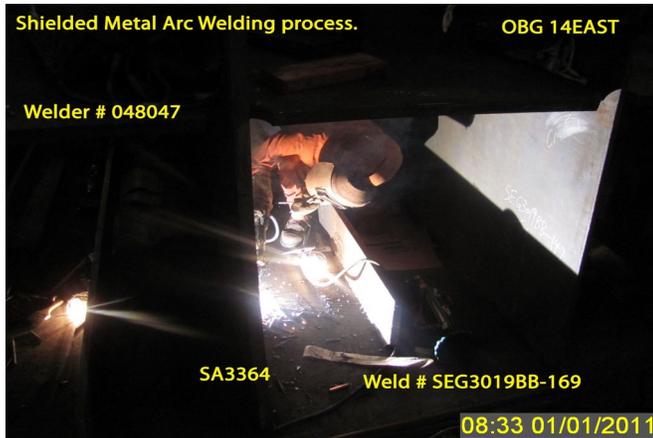
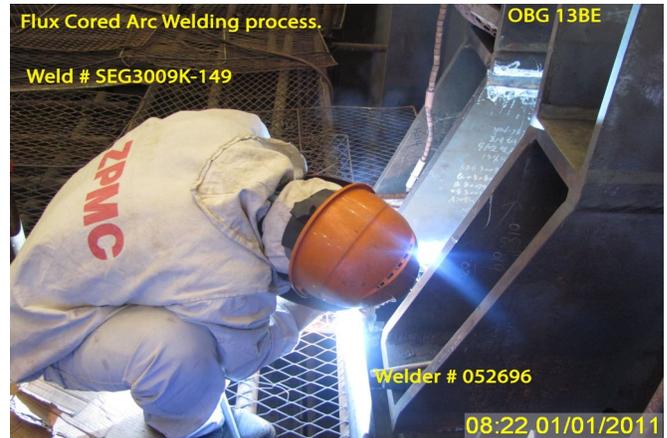
This Quality Assurance (QA) Inspector observed ZPMC qualified welder 052696 performing the Flux Cored Arc

Welding process on weld 149 located at PCMK SEG3019K. ZPMC QC Mr. Zong Yang Gang was monitoring this welding operation. The welding variables recorded by QC appeared to comply with WPS-B-T-2232-ESAB.

This Quality Assurance (QA) Inspector observed ZPMC qualified welder 048047 performing the Shielded Metal Arc Welding process on weld 169 located at PCMK SEG3019BB. ZPMC QC Mr. Zhong Guo Hui was monitoring this welding operation. The welding variables recorded by QC appeared to comply with WPS-B-P-2212-Tc-u4b-Fcm-1.
