**DEPARTMENT OF TRANSPORTATION**

Contract #: 04-0120F4Cty: SF/Ala Rte: 80 PM: 13.2/13.9File #: 69.28**WELDING INSPECTION REPORT****Resident Engineer:** Siegenthaler, Peter**Address:** 333 Burma Road**City:** Oakland, CA 94607**Report No:** WIR-019178**Date Inspected:** 28-Dec-2010**Project Name:** SAS Superstructure**OSM Arrival Time:** 1900**Prime Contractor:** American Bridge/Fluor Enterprises, a JV**OSM Departure Time:** 700**Contractor:** Zhenhua Port Machinery Company, Ltd (ZPMC), Changxing Island **Location:** Shanghai, China**CWI Name:** See below**CWI Present:** Yes No**Inspected CWI report:** Yes No N/A**Rod Oven in Use:** Yes No N/A**Electrode to specification:** Yes No N/A**Weld Procedures Followed:** Yes No N/A**Qualified Welders:** Yes No N/A**Verified Joint Fit-up:** Yes No N/A**Approved Drawings:** Yes No N/A**Approved WPS:** Yes No N/A**Delayed / Cancelled:** Yes No N/A**Bridge No:** 34-0006**Component:** OBG and Tower Components**Summary of Items Observed:**

# WELDING INSPECTION REPORT

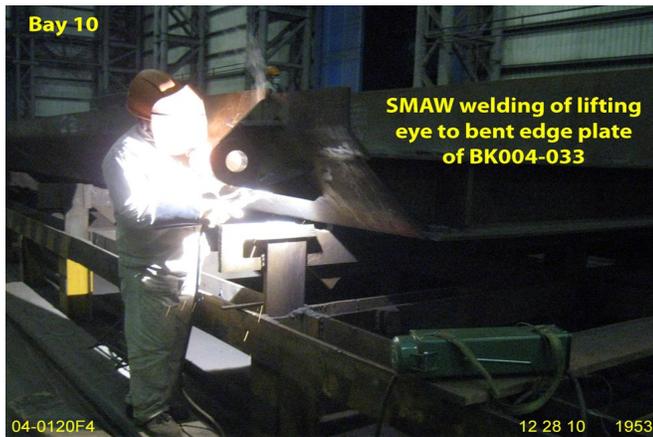
SMAW welding of temporary lifting eye to bent edge plate located on PCMK OBG BK004-033. Welder was identified as 052930. QC was identified as Zhao Chen Sun (QC1). Assisting QC1 at this location and appearing to be monitoring the welding operation and recording data was ZPMC QC Shao Hai Lang (QCA1), who was not a CWI. Weld variables recorded by QCA1 appeared to comply with WPS-B-P-2213 as verbally identified by QCA1. See photo below.
