**DEPARTMENT OF TRANSPORTATION**

Contract #: 04-0120F4Cty: SF/ALA Rte: 80 PM: 13.2/13.9File #: 69.28**WELDING INSPECTION REPORT****Resident Engineer:** Siegenthaler, Peter**Address:** 333 Burma Road**City:** Oakland, CA 94607**Report No:** WIR-019186**Date Inspected:** 04-Jan-2011**Project Name:** SAS Superstructure**OSM Arrival Time:** 700**Prime Contractor:** American Bridge/Fluor Enterprises, a JV**OSM Departure Time:** 1900**Contractor:** Zhenhua Port Machinery Company, Ltd (ZPMC), Changxing Island **Location:** Shanghai, China**CWI Name:** Liu Hua Jie**CWI Present:** Yes No**Inspected CWI report:** Yes No N/A**Rod Oven in Use:** Yes No N/A**Electrode to specification:** Yes No N/A**Weld Procedures Followed:** Yes No N/A**Qualified Welders:** Yes No N/A**Verified Joint Fit-up:** Yes No N/A**Approved Drawings:** Yes No N/A**Approved WPS:** Yes No N/A**Delayed / Cancelled:** Yes No N/A**Bridge No:** 34-0006**Component:** OBG COMPONENT**Summary of Items Observed:**

# WELDING INSPECTION REPORT

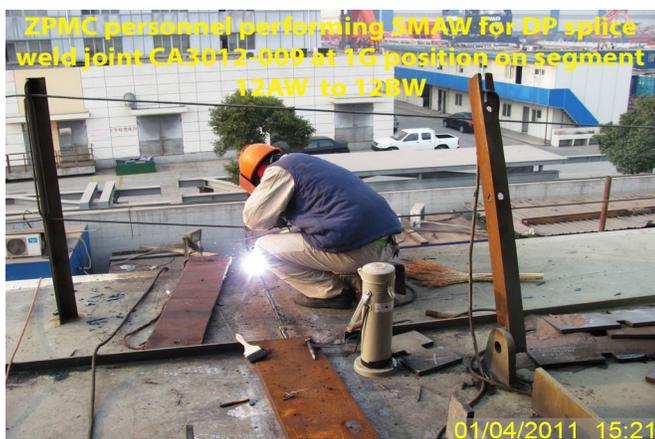
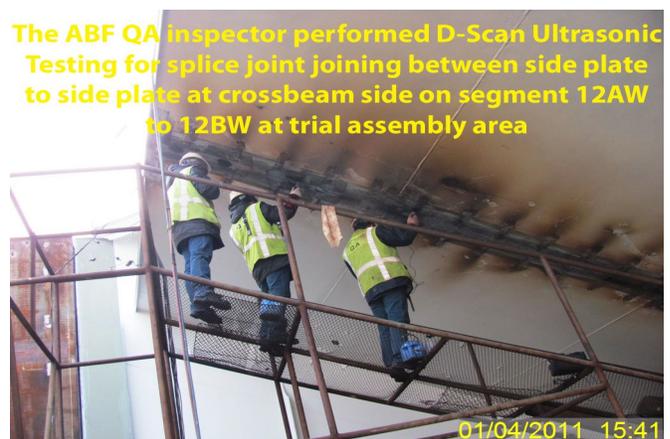
This QA Inspector performed Ultrasonic testing (UT) verification of the area previously tested and accepted by ABF Quality control personnel. This QA inspector generated a (UT) report for this date. The member is identified as splice joint joining between edge Plate to edge Plate for OBG segment 12AW to 12BW at cross beam side . The result was recorded onto a data sheet according to rejection criteria of “D” Scan procedure 001 rev.1 that Caltrans QA and ABF QA have jointly filled out on this date. The QA inspector found no rejectable indication at scanned area.

OBW12-003
