Quality Assurance and Source Inspection

Contract #: 04-0120F4Cty: SF/ALA Rte: 80 PM: 13.2/13.9File #: 69.28**WELDING INSPECTION REPORT****Resident Engineer:** Siegenthaler, Peter**Address:** 333 Burma Road**City:** Oakland, CA 94607**Report No:** WIR-019226**Date Inspected:** 01-Jan-2011**Project Name:** SAS Superstructure**OSM Arrival Time:** 700**Prime Contractor:** American Bridge/Fluor Enterprises, a JV**OSM Departure Time:** 1900**Contractor:** Zhenhua Port Machinery Company, Ltd (ZPMC), Changxing Island **Location:** Shanghai, China**CWI Name:** Liu Hua Jie**CWI Present:** Yes No**Inspected CWI report:** Yes No N/A**Rod Oven in Use:** Yes No N/A**Electrode to specification:** Yes No N/A**Weld Procedures Followed:** Yes No N/A**Qualified Welders:** Yes No N/A**Verified Joint Fit-up:** Yes No N/A**Approved Drawings:** Yes No N/A**Approved WPS:** Yes No N/A**Delayed / Cancelled:** Yes No N/A**Bridge No:** 34-0006**Component:** Orthotropic Box Girder (OBG)**Summary of Items Observed:**

OBG # TRIAL ASSEMBLY YARD

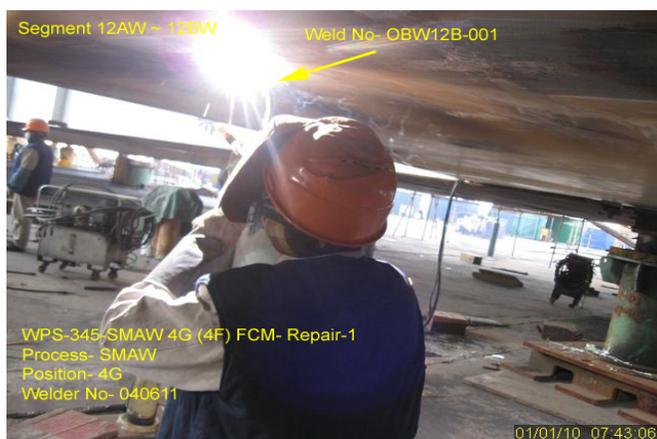
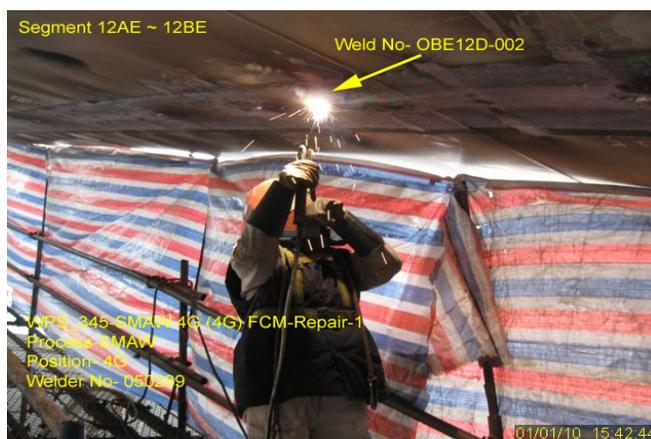
This QA Inspector observed ZPMC qualified welding personnel identified as 040611 perform Shielded Metal Arc Welding (SMAW), weld joint identified as OBW12B-001; located On Orthotropic Box Girder (OBG) Deck Plate to Edge Plate CJP Weld; The Welding Repair Report (WRR) was B-WR19714. ZPMC Quality Control (QC) is identified as Mr. Zhou Peng. The welding variables recorded by QC appeared to comply with applicable WPS-345-SMAW 4G (4F) FCM-Repair-1. See attached photo for further details.

Welding (SMAW), weld joint identified as OBE12D-002; located On Orthotropic Box Girder (OBG) Side Plate to Side Plate Transverse Splice CJP Weld; The Welding Repair Report (WRR) was B-WR19739. ZPMC Quality Control (QC) is identified as Mr. Wang Li Yang. The welding variables recorded by QC appeared to comply with applicable WPS-345-SMAW 4G (4F) FCM-Repair-1. See attached photo for further details.
