DEPARTMENT OF TRANSPORTATION

Contract #: 04-0120F4Cty: SF/ALA Rte: 80 PM: 13.2/13.9File #: 69.28**WELDING INSPECTION REPORT****Resident Engineer:** Siegenthaler, Peter**Address:** 333 Burma Road**City:** Oakland, CA 94607**Report No:** WIR-019251**Date Inspected:** 22-Nov-2010**Project Name:** SAS Superstructure**OSM Arrival Time:** 700**Prime Contractor:** American Bridge/Fluor Enterprises, a JV**OSM Departure Time:** 1900**Contractor:** Zhenhua Port Machinery Company, Ltd (ZPMC), Changxing Island **Location:** Shanghai, China**CWI Name:** Li Yan Hua.**CWI Present:** Yes No**Inspected CWI report:** Yes No N/A**Rod Oven in Use:** Yes No N/A**Electrode to specification:** Yes No N/A**Weld Procedures Followed:** Yes No N/A**Qualified Welders:** Yes No N/A**Verified Joint Fit-up:** Yes No N/A**Approved Drawings:** Yes No N/A**Approved WPS:** Yes No N/A**Delayed / Cancelled:** Yes No N/A**Bridge No:** 34-0006**Component:** OBG components.**Summary of Items Observed:**

WELDING INSPECTION REPORT

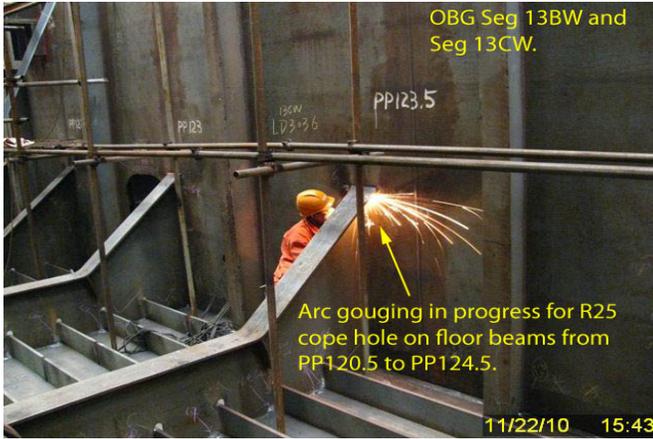
This QA Inspector observed ZPMC personnel doing arc gouging for R25 cope hole on the floor beams; from PP120.5 to 124.5. Welding and NDT (UT) of FB to longitudinal diaphragm (LD) CJP weld from PP120.5 to 124.5 is completed. See attached photos for further details.
