DEPARTMENT OF TRANSPORTATION

Quality Assurance and Source Inspection

Contract #: 04-0120F4Cty: SF/ALA Rte: 80 PM: 13.2/13.9File #: 69.28**WELDING INSPECTION REPORT****Resident Engineer:** Siegenthaler, Peter**Address:** 333 Burma Road**City:** Oakland, CA 94607**Report No:** WIR-019264**Date Inspected:** 20-Dec-2010**Project Name:** SAS Superstructure**OSM Arrival Time:** 700**Prime Contractor:** American Bridge/Fluor Enterprises, a JV**OSM Departure Time:** 1900**Contractor:** Zhenhua Port Machinery Company, Ltd (ZPMC), Changxing Island **Location:** Shanghai, China**CWI Name:** Qiu Wen.**CWI Present:** Yes No**Inspected CWI report:** Yes No N/A**Rod Oven in Use:** Yes No N/A**Electrode to specification:** Yes No N/A**Weld Procedures Followed:** Yes No N/A**Qualified Welders:** Yes No N/A**Verified Joint Fit-up:** Yes No N/A**Approved Drawings:** Yes No N/A**Approved WPS:** Yes No N/A**Delayed / Cancelled:** Yes No N/A**Bridge No:** 34-0006**Component:** OBG components.**Summary of Items Observed:**

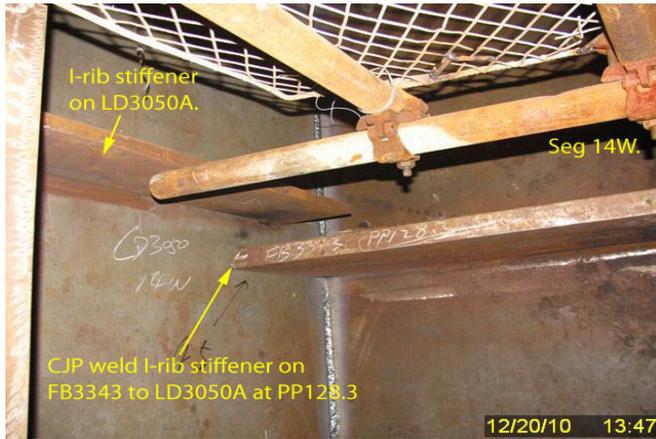
During random inprocess visual inspection, this QA Inspector observed that the I-rib stiffener on FB3343A needs to be CJP welded with LD3050A at PP128.3. However, it was noted that due to the I-rib stiffener welded on LD3050A, there is less access to weld the above mentioned CJP weld. This is informed to ZPMC CWI, identified as Qiu Wen. See attached photo for details.

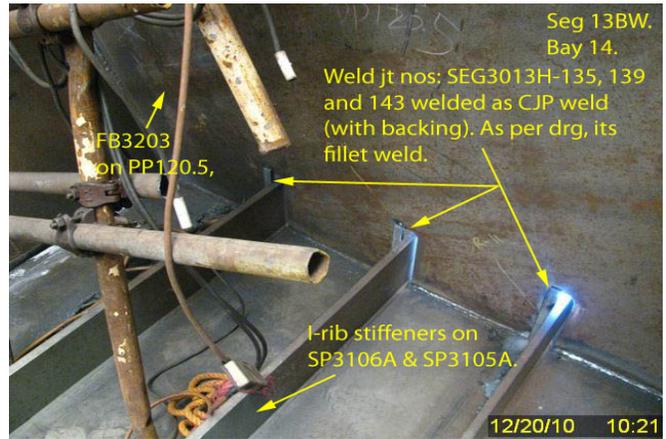
The FCAW process on weld joint nos: SEG3014H-135, 239 and 143 (FB3203A to I-rib stiffeners on SP3106A, at PP120.5). The welder is identified as 045209 and was observed welding in the 3G position. ZPMC QC was identified as Qiu Wen. The welding variables recorded by QC appeared to comply with WPS: B-T-2233-ESAB.

These welds are welded as CJP welds (instead of fillet welds, as required in drg) due to excess root gap (approx 11-12mm). See attached photo for details.
