DEPARTMENT OF TRANSPORTATION

Quality Assurance and Source Inspection

Contract #: 04-0120F4Cty: SF/ALA Rte: 80 PM: 13.2/13.9File #: 69.28**WELDING INSPECTION REPORT****Resident Engineer:** Siegenthaler, Peter**Address:** 333 Burma Road**City:** Oakland, CA 94607**Report No:** WIR-019266**Date Inspected:** 22-Dec-2010**Project Name:** SAS Superstructure**OSM Arrival Time:** 700**Prime Contractor:** American Bridge/Fluor Enterprises, a JV**OSM Departure Time:** 1900**Contractor:** Zhenhua Port Machinery Company, Ltd (ZPMC), Changxing Island **Location:** Shanghai, China**CWI Name:** Qiu Wen.**CWI Present:** Yes No**Inspected CWI report:** Yes No N/A**Rod Oven in Use:** Yes No N/A**Electrode to specification:** Yes No N/A**Weld Procedures Followed:** Yes No N/A**Qualified Welders:** Yes No N/A**Verified Joint Fit-up:** Yes No N/A**Approved Drawings:** Yes No N/A**Approved WPS:** Yes No N/A**Delayed / Cancelled:** Yes No N/A**Bridge No:** 34-0006**Component:** OBG components.**Summary of Items Observed:**

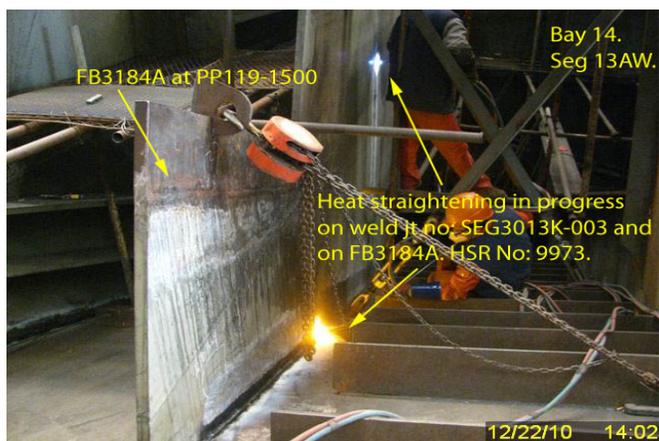
ZPMC personnel performing heat straightening on weld jt no: SEG3013K-003 [Floor Beam (FB) 3184A to Side Panel (SP) 3101A, complete joint penetration (CJP) weld at panel point (PP) 119-1500] and on FB3184A (at SA3167A). Heat straightening was done as per heat straightening report (HSR): 9973. Heat straightening was done to correct the distortion of FB after welding. ZPMC QC was identified as Liming Yang. See attached photo for details.
