**DEPARTMENT OF TRANSPORTATION**

Contract #: 04-0120F4Cty: SF/ALA Rte: 80 PM: 13.2/13.9File #: 69.28**WELDING INSPECTION REPORT****Resident Engineer:** Siegenthaler, Peter**Address:** 333 Burma Road**City:** Oakland, CA 94607**Report No:** WIR-019268**Date Inspected:** 24-Dec-2010**Project Name:** SAS Superstructure**OSM Arrival Time:** 700**Prime Contractor:** American Bridge/Fluor Enterprises, a JV**OSM Departure Time:** 1900**Contractor:** Zhenhua Port Machinery Company, Ltd (ZPMC), Changxing Island **Location:** Shanghai, China**CWI Name:** Qiu Wen.**CWI Present:** Yes No**Inspected CWI report:** Yes No N/A**Rod Oven in Use:** Yes No N/A**Electrode to specification:** Yes No N/A**Weld Procedures Followed:** Yes No N/A**Qualified Welders:** Yes No N/A**Verified Joint Fit-up:** Yes No N/A**Approved Drawings:** Yes No N/A**Approved WPS:** Yes No N/A**Delayed / Cancelled:** Yes No N/A**Bridge No:** 34-0006**Component:** OBG components.**Summary of Items Observed:**

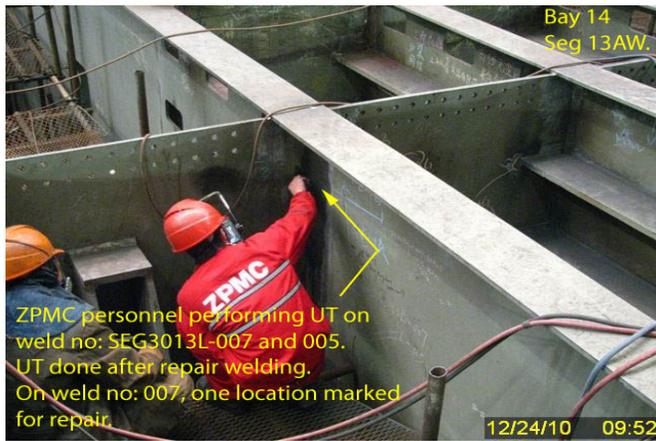
ZPMC NDT personnel performing Ultrasonic testing (UT) of weld joint no: SEG3013L-005 and 007 (FB to LD, CJP weld at PP 119-1500). UT was done after completion of repair welding. Still, on weld jt no: 007, at one location, repair was identified. See attached photo for details.
