DEPARTMENT OF TRANSPORTATION

Contract #: 04-0120F4Cty: SF/Ala Rte: 80 PM: 13.2/13.9File #: 69.28**WELDING INSPECTION REPORT****Resident Engineer:** Siegenthaler, Peter**Address:** 333 Burma Road**City:** Oakland, CA 94607**Report No:** WIR-019291**Date Inspected:** 02-Jan-2011**Project Name:** SAS Superstructure**OSM Arrival Time:** 1900**Prime Contractor:** American Bridge/Fluor Enterprises, a JV**OSM Departure Time:** 700**Contractor:** Zhenhua Port Machinery Company, Ltd (ZPMC), Changxing Island **Location:** Shanghai, China**CWI Name:** See below**CWI Present:** Yes No**Inspected CWI report:** Yes No N/A**Rod Oven in Use:** Yes No N/A**Electrode to specification:** Yes No N/A**Weld Procedures Followed:** Yes No N/A**Qualified Welders:** Yes No N/A**Verified Joint Fit-up:** Yes No N/A**Approved Drawings:** Yes No N/A**Approved WPS:** Yes No N/A**Delayed / Cancelled:** Yes No N/A**Bridge No:** 34-0006**Component:** Tower and OBG Components**Summary of Items Observed:**

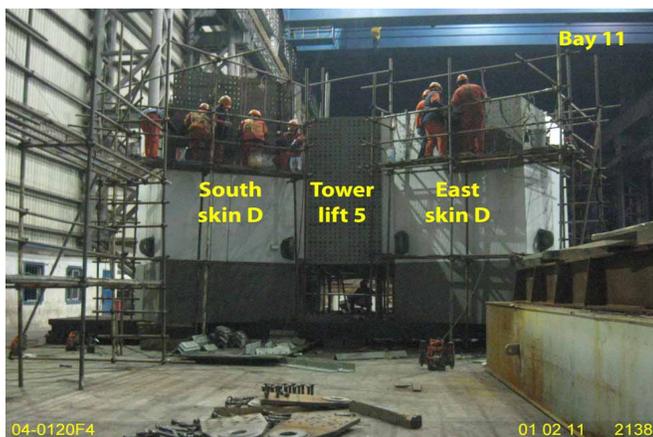
ZPMC workers were performing match drilling operations at the top of east and south towers, lift 5, skin D and drilling various other parts at the floor level, all using magnetically attached drill presses. See photo below.
