DEPARTMENT OF TRANSPORTATION

Contract #: 04-0120F4Cty: SF/ALA Rte: 80 PM: 13.2/13.9File #: 69.28**WELDING INSPECTION REPORT****Resident Engineer:** Siegenthaler, Peter**Address:** 333 Burma Road**City:** Oakland, CA 94607**Report No:** WIR-019293**Date Inspected:** 18-Jan-2011**Project Name:** SAS Superstructure**OSM Arrival Time:** 700**Prime Contractor:** American Bridge/Fluor Enterprises, a JV**OSM Departure Time:** 1900**Contractor:** Zhenhua Port Machinery Company, Ltd (ZPMC), Changxing Island **Location:** Shanghai, China**CWI Name:** Liu Hua Jie**CWI Present:** Yes No**Inspected CWI report:** Yes No N/A**Rod Oven in Use:** Yes No N/A**Electrode to specification:** Yes No N/A**Weld Procedures Followed:** Yes No N/A**Qualified Welders:** Yes No N/A**Verified Joint Fit-up:** Yes No N/A**Approved Drawings:** Yes No N/A**Approved WPS:** Yes No N/A**Delayed / Cancelled:** Yes No N/A**Bridge No:** 34-0006**Component:** OBG COMPONENT**Summary of Items Observed:**

WELDING INSPECTION REPORT

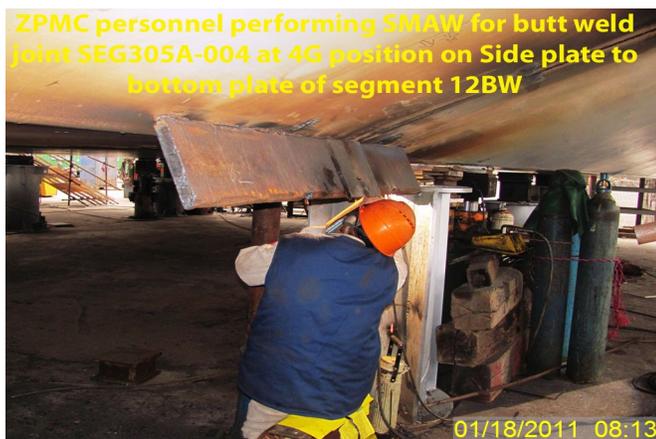
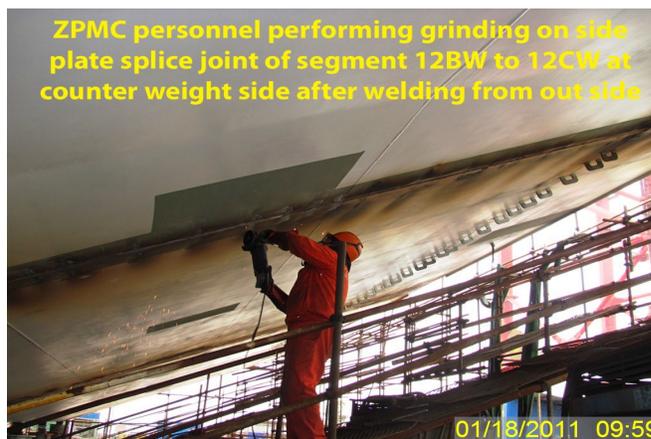
SMAW in the 1G position for the OBG Segment 12BW to 12CW weld No.OBW12A-002. The welder is identified as #044551. ZPMC QC is identified as Mr.Zhou Zhong Hai. The welding variables recorded by QC appear to comply with WPS-B-P-2211-B-U2-FCM-1.

SMAW in the 4G position for the OBG Segment 12BW weld No.SEG3005A-004. The welder is identified as #040611. ZPMC QC is identified as Mr.Zhou Peng. The welding variables recorded by QC appear to comply with WPS-B-P-2214-B-U2-FCM-1.

SMAW in the 4G position for the OBG Segment 12CW weld No.SEG3006A-011. The welder is identified as #040611. ZPMC QC is identified as Mr.Zhou Peng. The welding variables recorded by QC appear to comply with WPS-B-P-2214-B-U2-FCM-1.

SMAW in the 2G position for the OBG Segment 12BW weld No.SEG3005M-090. The welder is identified as #046704. ZPMC QC is identified as Mr. Shi Lie. The welding variables recorded by QC appear to comply with WPS-B-P-2212-T-U4b-FCM-1.

SMAW in the 2G position for the OBG Segment 12CW weld No.SEG3006S-035. The welder is identified as #046704. ZPMC QC is identified as Mr. Shi Lie. The welding variables recorded by QC appear to comply with WPS-B-P-2212-T-U4b-FCM-1.

- The component for verification was identified as Bike path BK4A-064
- Base metal repair was to be performed on location where lifting lugs and stiffeners removed area
- ZPMC QC Liu Chuan Gang was present on site to direct and record all repair work.
- WPS to be used for repair were WPS-345-SMAW-1G(1F)-Repair and WPS-345-SMAW-3G(3F)-Repair
