DEPARTMENT OF TRANSPORTATION

Contract #: 04-0120F4Cty: SF/ALA Rte: 80 PM: 13.2/13.9File #: 99.28**WELDING INSPECTION REPORT****Resident Engineer:** Siegenthaler, Peter**Address:** 333 Burma Road**City:** Oakland, CA 94607**Report No:** WIR-019311**Date Inspected:** 12-Jan-2011**Project Name:** SAS Superstructure**OSM Arrival Time:** 1100**Prime Contractor:** American Bridge/Fluor Enterprises, a JV**OSM Departure Time:** 1900**Contractor:** Zhenhua Port Machinery Company, Ltd (ZPMC) Chanxing Island**Location:** Shanghai, China**CWI Name:** Mr. Qui Wen**CWI Present:** Yes No**Inspected CWI report:** Yes No N/A**Rod Oven in Use:** Yes No N/A**Electrode to specification:** Yes No N/A**Weld Procedures Followed:** Yes No N/A**Qualified Welders:** Yes No N/A**Verified Joint Fit-up:** Yes No N/A**Approved Drawings:** Yes No N/A**Approved WPS:** Yes No N/A**Delayed / Cancelled:** Yes No N/A**Bridge No:** 34-0006**Component:** OBG Segment**Summary of Items Observed:**

WELDING INSPECTION REPORT

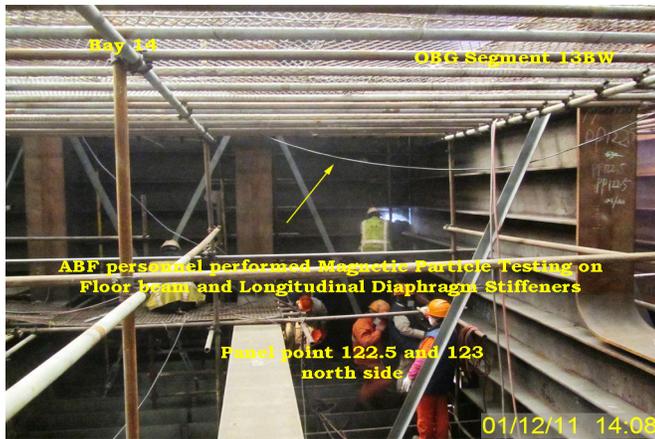
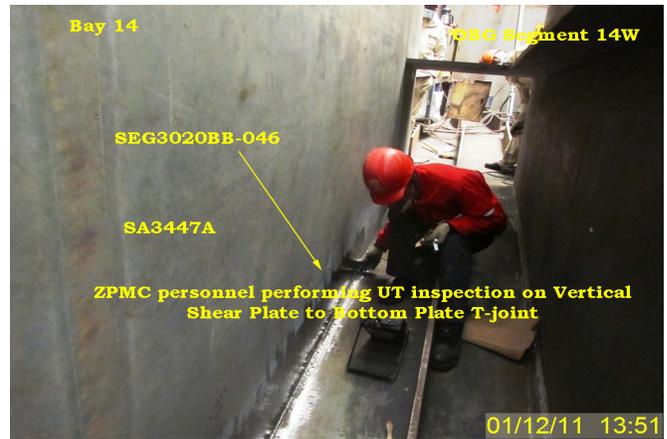
This QA inspector observed ZPMC personnel performed Ultrasonic Testing on Vertical Share Plate to Bottom plate of the OBG Segment 14W. The weld numbers are identified as SEG3020BB-046, 055 and 037. See the attached picture.
