Contract #: 04-0120F4Cty: SF/ALA Rte: 80 PM: 13.2/13.9File #: 99.28**WELDING INSPECTION REPORT****Resident Engineer:** Siegenthaler, Peter**Address:** 333 Burma Road**City:** Oakland, CA 94607**Report No:** WIR-019316**Date Inspected:** 04-Jan-2011**Project Name:** SAS Superstructure**OSM Arrival Time:** 700**Prime Contractor:** American Bridge/Fluor Enterprises, a JV**OSM Departure Time:** 1900**Contractor:** Zhenhua Port Machinery Company, Ltd (ZPMC) Chanxing Island**Location:** Shanghai, China

Bridge No: 34-0006**Component:** OBG Segment**Summary of Items Observed:**

WELDING INSPECTION REPORT

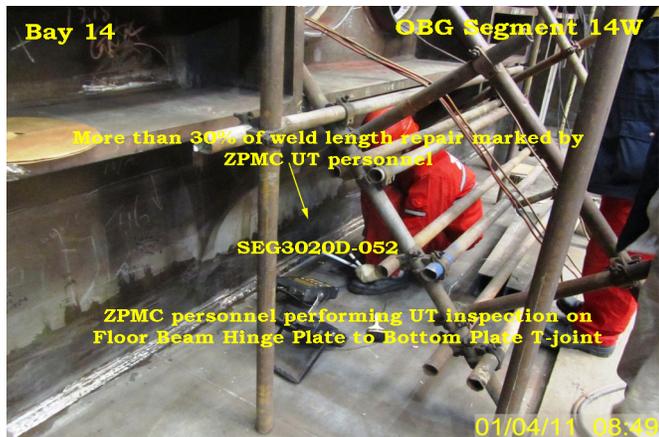
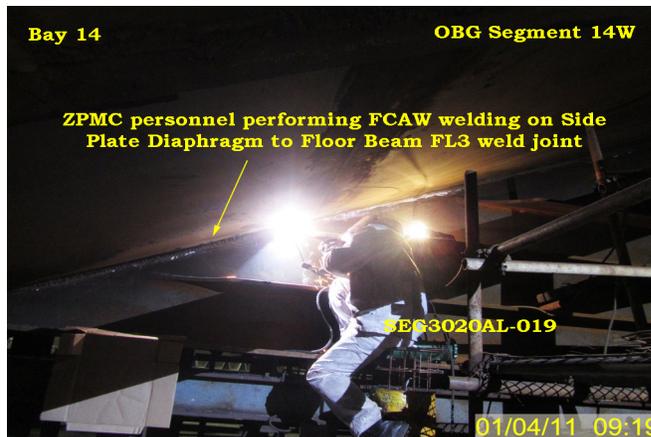
This QA inspector observed ZPMC personnel performed Ultrasonic Testing on Floor Beam Hinge Plate to Bottom Plate T joint of the OBG Segment 14E and the weld is identified as SEG3020D-052. More than 30% of weld

length repair marked by ZPMC UT personnel. See the attached picture.
