DEPARTMENT OF TRANSPORTATION

Quality Assurance and Source Inspection

Contract #: 04-0120F4Cty: SF/ALA Rte: 80 PM: 13.2/13.9File #: 69.28**WELDING INSPECTION REPORT****Resident Engineer:** Siegenthaler, Peter**Address:** 333 Burma Road**City:** Oakland, CA 94607**Report No:** WIR-019324**Date Inspected:** 11-Jan-2011**Project Name:** SAS Superstructure**OSM Arrival Time:** 700**Prime Contractor:** American Bridge/Fluor Enterprises, a JV**OSM Departure Time:** 1900**Contractor:** Zhenhua Port Machinery Company, Ltd (ZPMC), Changxing Island **Location:** Shanghai, China**CWI Name:** Cheng Xi**CWI Present:** Yes No**Inspected CWI report:** Yes No N/A**Rod Oven in Use:** Yes No N/A**Electrode to specification:** Yes No N/A**Weld Procedures Followed:** Yes No N/A**Qualified Welders:** Yes No N/A**Verified Joint Fit-up:** Yes No N/A**Approved Drawings:** Yes No N/A**Approved WPS:** Yes No N/A**Delayed / Cancelled:** Yes No N/A**Bridge No:** 34-0006**Component:** OBG**Summary of Items Observed:**

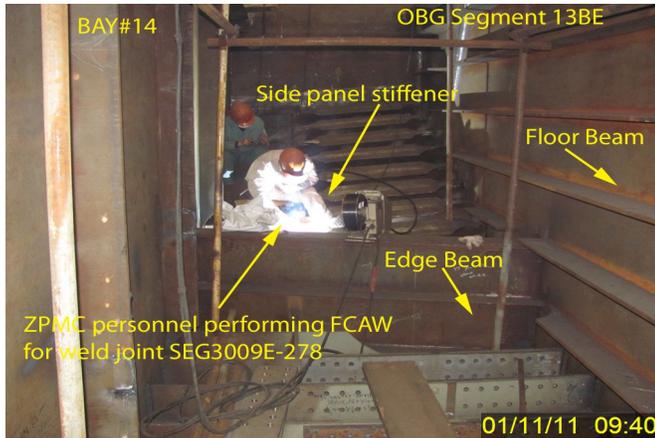
FCAW in the 3G position for the OBG Segment 13BE Side panel stiffener to Side panel stiffeners. The weld joint was designated as: SEG3009E-278. The welder is identified as #052696. ZPMC QC is identified as Mr. Zhong yong hong. The welding variables recorded by QC appear to comply with WPS-B-T-2233-ESAB. Please see the

attached picture.

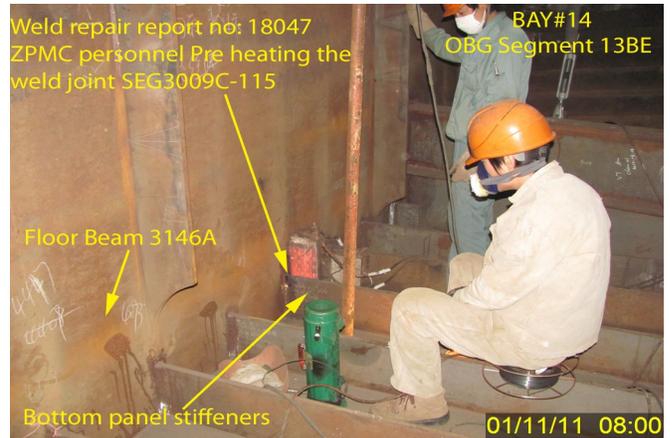
SMAW welding of weld joint no: SEG3009C-115 located on OBG Segment 13BE Bottom panel stiffener to Floor beam. Welder is identified as #048047. ZPMC CWI is identified as Mr. Cheng Xi. Welding was performed according to the weld repair report B-WR18047.The welding variables recorded by QC appeared to comply with the WPS-345-SMAW-3G(3F)-FCM-Repair-1.Please see the attached picture.
