Contract #: 04-0120F4Cty: SF/ALA Rte: 80 PM: 13.2/13.9File #: 69.28**WELDING INSPECTION REPORT****Resident Engineer:** Siegenthaler, Peter**Address:** 333 Burma Road**City:** Oakland, CA 94607**Report No:** WIR-019356**Date Inspected:** 21-Dec-2010**Project Name:** SAS Superstructure**OSM Arrival Time:** 700**Prime Contractor:** American Bridge/Fluor Enterprises, a JV**OSM Departure Time:** 1900**Contractor:** Zhenhua Port Machinery Company, Ltd (ZPMC), Changxing Island **Location:** Shanghai, China**CWI Name:** Mr. Zhu Zhong Hai.**CWI Present:** Yes No**Inspected CWI report:** Yes No N/A**Rod Oven in Use:** Yes No N/A**Electrode to specification:** Yes No N/A**Weld Procedures Followed:** Yes No N/A**Qualified Welders:** Yes No N/A**Verified Joint Fit-up:** Yes No N/A**Approved Drawings:** Yes No N/A**Approved WPS:** Yes No N/A**Delayed / Cancelled:** Yes No N/A**Bridge No:** 34-0006**Component:** Orthotropic Box Girder (OBG)**Summary of Items Observed:**

On this day CALTRANS OSM Quality Assurance (QA) Inspector Shailesh Gaikwad was present during the times noted above for observations relative to the fabrication of the SAS Superstructure being performed by Zhenhua Port Machinery

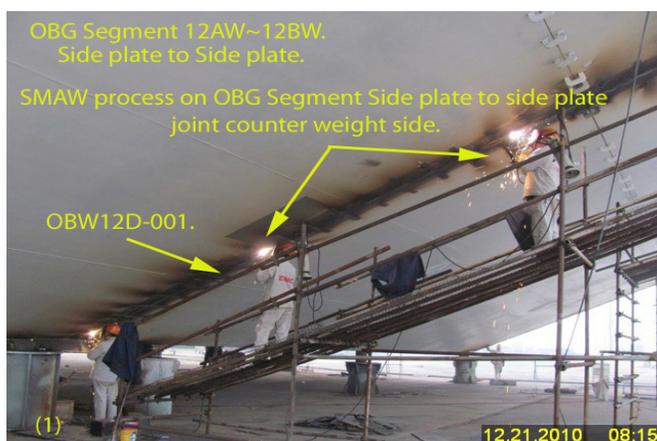
This QA Inspector observed ZPMC qualified welding personnel identified as 040656, 040611 Perform Shielded Metal Arc Welding (SMAW) on OBG segment 12AW +12BW Side plate to Side plate joint Counter weight side. Joint identified as OBW12D-001. ZPMC QC Identified as Shi Lei. The welding parameters as measured using QC's calibrated instrument appeared to be in general compliance with WPS-B-P-2214-B-U2-FCM-1. For more information see below attached picture number 1.

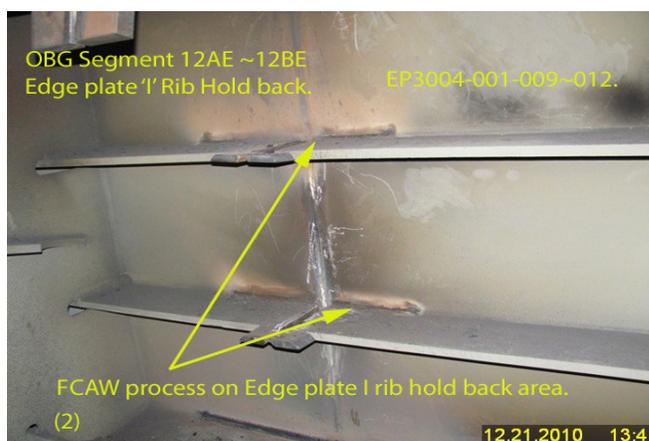
This QA Inspector observed ZPMC qualified welding personnel identified as 047353 Perform Flux Core Arc Welding (FCAW) on OBG segment 12AE~12BE I rib hold back area of Edge plate bike path side. Joint identified as EP3004-001-009~012. ZPMC QC Identified as Liu Hua Jie. The welding parameters as measured using QC's calibrated instrument appeared to be in general compliance with WPS-B-T-2232-ESAB. For more information see below attached picture number 2.
