DEPARTMENT OF TRANSPORTATION

Quality Assurance and Source Inspection

Contract #: 04-0120F4Cty: SF/Ala Rte: 80 PM: 13.2/13.9File #: 69.28**WELDING INSPECTION REPORT****Resident Engineer:** Siegenthaler, Peter**Address:** 333 Burma Road**City:** Oakland, CA 94607**Report No:** WIR-019366**Date Inspected:** 14-Jan-2011**Project Name:** SAS Superstructure**OSM Arrival Time:** 1900**Prime Contractor:** American Bridge/Fluor Enterprises, a JV**OSM Departure Time:** 700**Contractor:** Zhenhua Port Machinery Company, Ltd (ZPMC), Changxing Island **Location:** Shanghai, China**CWI Name:** See below**CWI Present:** Yes No**Inspected CWI report:** Yes No N/A**Rod Oven in Use:** Yes No N/A**Electrode to specification:** Yes No N/A**Weld Procedures Followed:** Yes No N/A**Qualified Welders:** Yes No N/A**Verified Joint Fit-up:** Yes No N/A**Approved Drawings:** Yes No N/A**Approved WPS:** Yes No N/A**Delayed / Cancelled:** Yes No N/A**Bridge No:** 34-0006**Component:** Tower and OBG Components**Summary of Items Observed:**

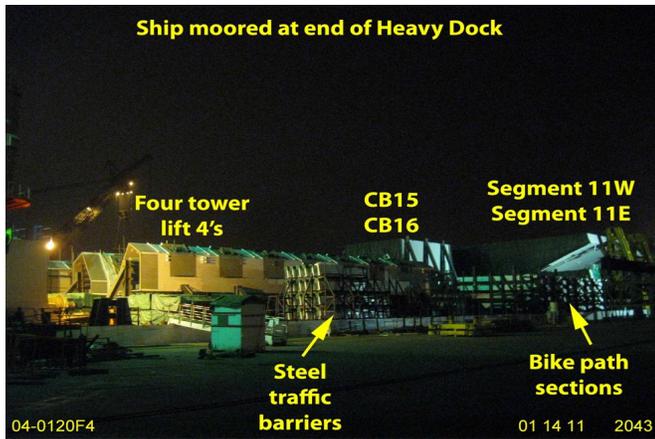
This QA Inspector randomly observed no apparent work in progress on the Heavy Dock. Several bundles of steel traffic barriers, several unidentified bundles of parts wrapped for shipping, and 1 bike path section were positioned on the Heavy Dock. OBG segments 11E and 11W; four tower, lift 4's; sections CB15 and CB16; several bundles of steel traffic barriers; and 18 bike path sections were on the deck of the ship moored at the end of the heavy dock.

See the photo below showing part of the deck of the ship.
