**DEPARTMENT OF TRANSPORTATION**

Quality Assurance and Source Inspection

Contract #: 04-0120F4Cty: SF/ALA Rte: 80 PM: 13.2/13.9File #: 74.28**WELDING INSPECTION REPORT****Resident Engineer:** Siegenthaler, Peter**Address:** 333 Burma Road**City:** Oakland, CA 94607**Report No:** WIR-019375**Date Inspected:** 10-Jan-2011**Project Name:** SAS Superstructure**OSM Arrival Time:** 900**Prime Contractor:** American Bridge/Fluor Enterprises, a JV**OSM Departure Time:** 1730**Contractor:** Goodwin Steel, UK**Location:** Trentham, UK

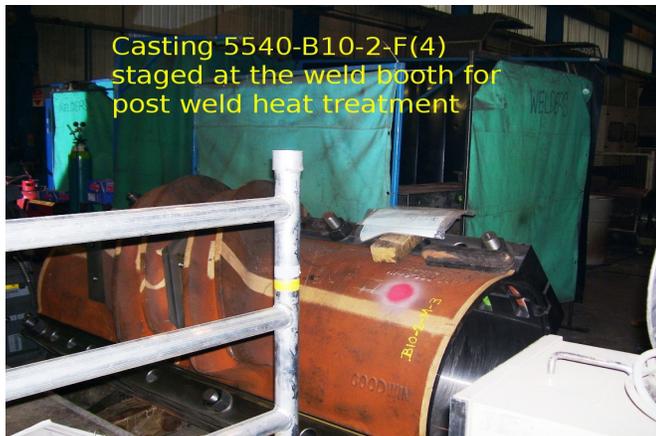
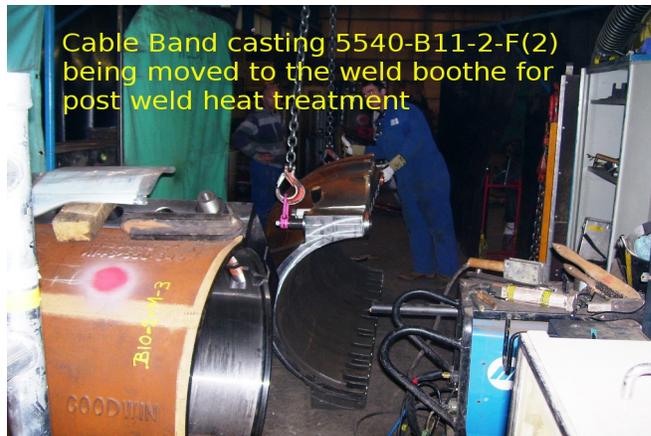
The cable band for east panel point 62, a B6 Type 1 cable band was observed under localized heat treatment. The trace on the heat treatment chart appeared to be unusual in that the programmed ramp rate for the temperature was not tracking. This was pointed out to Mr. Dan McDonagh, welder who verified with a Tempilstik that the temperature of the casting was not tracking with the temperature displayed on the chart recorder. The heat treatment was halted and the setup will be reviewed prior to recommencement of the heat treatment. The casting temperature was ramping up, and the casting did not reach the heat treatment temperature. This was verified with a Tempilstik.
