Quality Assurance and Source Inspection

Contract #: 04-0120F4Cty: SF/ALA Rte: 80 PM: 13.2/13.9File #: 69.28**WELDING INSPECTION REPORT****Resident Engineer:** Siegenthaler, Peter**Address:** 333 Burma Road**City:** Oakland, CA 94607**Report No:** WIR-019403**Date Inspected:** 13-Jan-2011**Project Name:** SAS Superstructure**OSM Arrival Time:** 700**Prime Contractor:** American Bridge/Fluor Enterprises, a JV**OSM Departure Time:** 1900**Contractor:** Zhenhua Port Machinery Company, Ltd (ZPMC), Changxing Island **Location:** Shanghai, China**CWI Name:** Mr. An Qing xiang**CWI Present:** Yes No**Inspected CWI report:** Yes No N/A**Rod Oven in Use:** Yes No N/A**Electrode to specification:** Yes No N/A**Weld Procedures Followed:** Yes No N/A**Qualified Welders:** Yes No N/A**Verified Joint Fit-up:** Yes No N/A**Approved Drawings:** Yes No N/A**Approved WPS:** Yes No N/A**Delayed / Cancelled:** Yes No N/A**Bridge No:** 34-0006**Component:** Orthotropic Box Girder (OBG)**Summary of Items Observed:**

WELDING INSPECTION REPORT

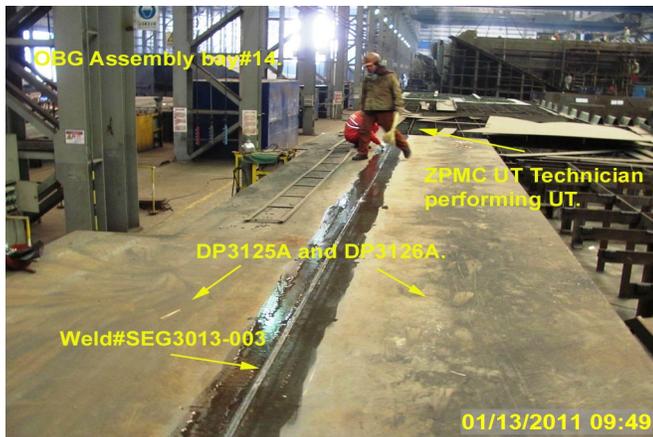
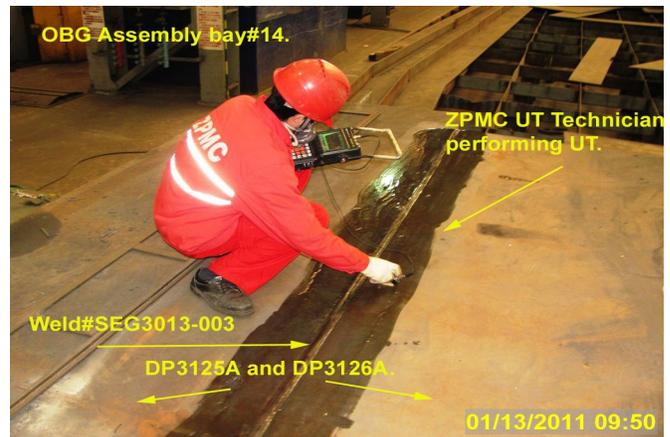
ZPMC UT Technician was performing Ultrasonic Testing for the deck panel splice weld joint identified as SEG3013-003. Refer the attached photos for reference.
