Contract #: 04-0120F4Cty: SF/ALA Rte: 80 PM: 13.2/13.9File #: 69.28**WELDING INSPECTION REPORT****Resident Engineer:** Siegenthaler, Peter**Address:** 333 Burma Road**City:** Oakland, CA 94607**Report No:** WIR-019404**Date Inspected:** 15-Jan-2011**Project Name:** SAS Superstructure**OSM Arrival Time:** 700**Prime Contractor:** American Bridge/Fluor Enterprises, a JV**OSM Departure Time:** 1500**Contractor:** Zhenhua Port Machinery Company, Ltd (ZPMC), Changxing Island **Location:** Shanghai, China**CWI Name:** Mr. An Qing xiang**CWI Present:** Yes No**Inspected CWI report:** Yes No N/A**Rod Oven in Use:** Yes No N/A**Electrode to specification:** Yes No N/A**Weld Procedures Followed:** Yes No N/A**Qualified Welders:** Yes No N/A**Verified Joint Fit-up:** Yes No N/A**Approved Drawings:** Yes No N/A**Approved WPS:** Yes No N/A**Delayed / Cancelled:** Yes No N/A**Bridge No:** 34-0006**Component:** Orthotropic Box Girder (OBG)**Summary of Items Observed:**

OBG Assembly Bay- 14.

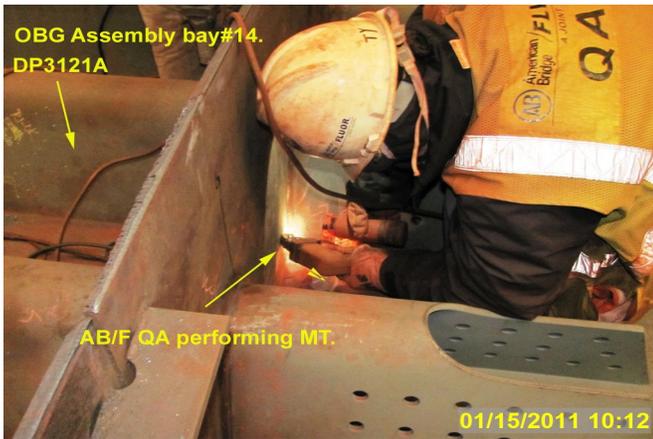
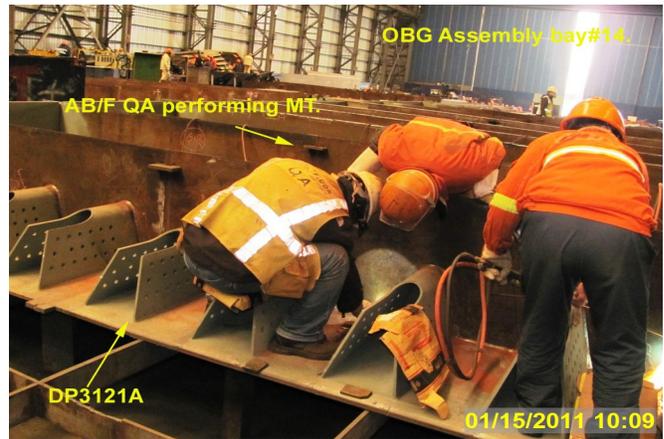
American Bridge/Fluor QA Inspector was performing Magnetic Particle Testing for the deck panel weld joints located on DP3121A. Refer the attached photos for reference.
