Contract #: 04-0120F4Cty: SF/ALA Rte: 80 PM: 13.2/13.9File #: 69.28**WELDING INSPECTION REPORT****Resident Engineer:** Siegenthaler, Peter**Address:** 333 Burma Road**City:** Oakland, CA 94607**Report No:** WIR-019409**Date Inspected:** 29-Dec-2010**Project Name:** SAS Superstructure**OSM Arrival Time:** 700**Prime Contractor:** American Bridge/Fluor Enterprises, a JV**OSM Departure Time:** 1900**Contractor:** Zhenhua Port Machinery Company, Ltd (ZPMC), Changxing Island **Location:** Shanghai, China**CWI Name:** Qiu Wen.**CWI Present:** Yes No**Inspected CWI report:** Yes No N/A**Rod Oven in Use:** Yes No N/A**Electrode to specification:** Yes No N/A**Weld Procedures Followed:** Yes No N/A**Qualified Welders:** Yes No N/A**Verified Joint Fit-up:** Yes No N/A**Approved Drawings:** Yes No N/A**Approved WPS:** Yes No N/A**Delayed / Cancelled:** Yes No N/A**Bridge No:** 34-0006**Component:** OBG components.**Summary of Items Observed:**

WELDING INSPECTION REPORT

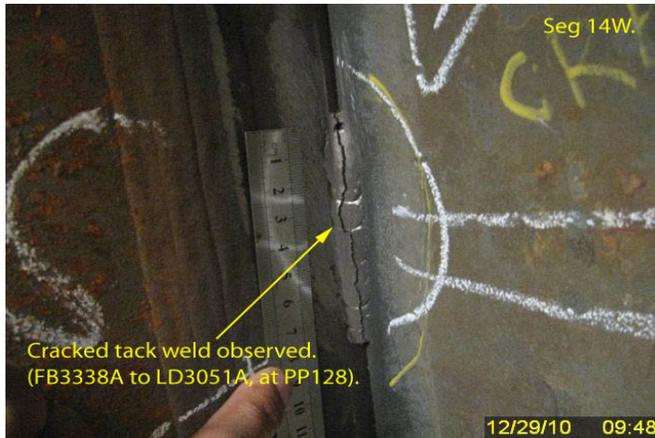
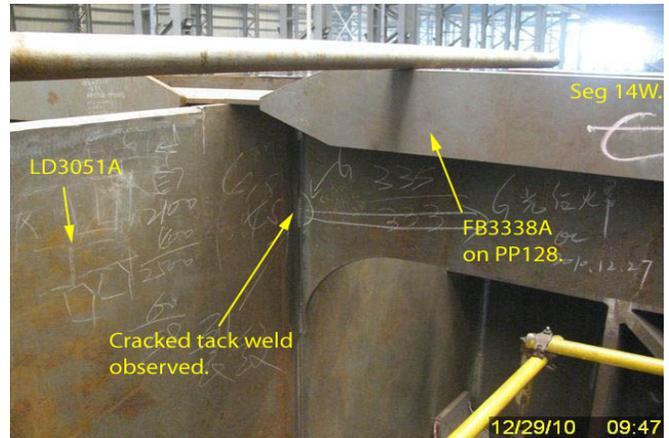
During random inprocess visual inspection, this QA inspector observed a cracked tack weld (FB3338A to LD3051A, at PP128). This is informed to ZPMC QC, identified as Zhu Lin. See attached photos for reference.
