**DEPARTMENT OF TRANSPORTATION**

Quality Assurance and Source Inspection

Contract #: 04-0120F4Cty: SF/ALA Rte: 80 PM: 13.2/13.9File #: 69.28**WELDING INSPECTION REPORT****Resident Engineer:** Siegenthaler, Peter**Address:** 333 Burma Road**City:** Oakland, CA 94607**Report No:** WIR-019410**Date Inspected:** 28-Dec-2010**Project Name:** SAS Superstructure**OSM Arrival Time:** 700**Prime Contractor:** American Bridge/Fluor Enterprises, a JV**OSM Departure Time:** 1900**Contractor:** Zhenhua Port Machinery Company, Ltd (ZPMC), Changxing Island **Location:** Shanghai, China**CWI Name:** Qiu Wen.**CWI Present:** Yes No**Inspected CWI report:** Yes No N/A**Rod Oven in Use:** Yes No N/A**Electrode to specification:** Yes No N/A**Weld Procedures Followed:** Yes No N/A**Qualified Welders:** Yes No N/A**Verified Joint Fit-up:** Yes No N/A**Approved Drawings:** Yes No N/A**Approved WPS:** Yes No N/A**Delayed / Cancelled:** Yes No N/A**Bridge No:** 34-0006**Component:** OBG components.**Summary of Items Observed:**

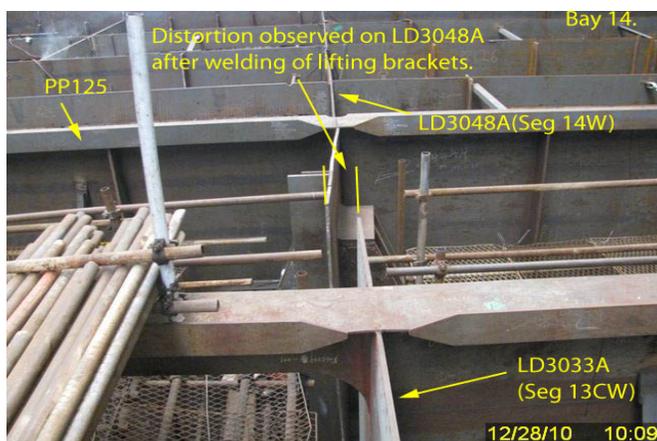
During inprocess visual inspection, this QA Inspector observed that the alignment of Longitudinal Diaphragm

(LD) 3048A of Seg 14W and LD3033A of Seg 13CW needs to be corrected. This was observed after the completion of welding of lifting bracket on LD3048A. This is informed to ZPMC CWI Qiu Wen and ABF QA Qasi Wang. See attached photo for reference.

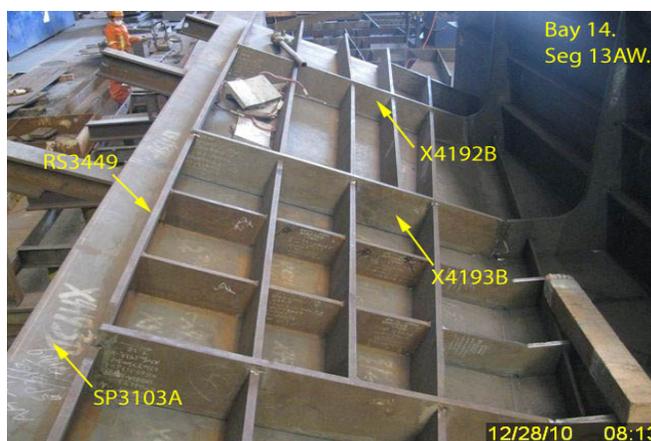
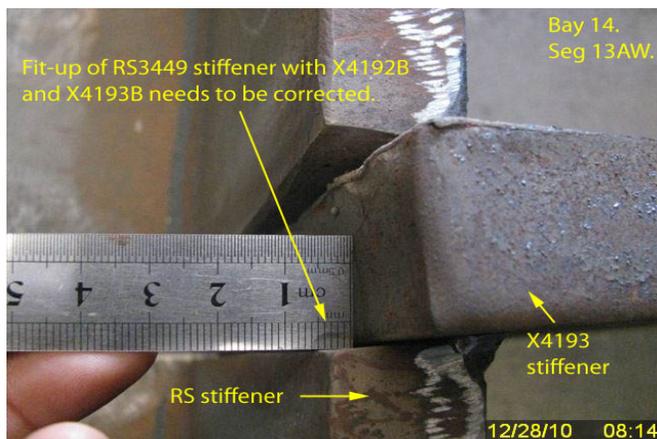
During random inprocess visual inspection of RS stiffeners (RS3449) with X4193B on Side Panel (SP) 3103B, this QA Inspector observed that the RS stiffeners are not aligned with X4193B. This needs to be corrected by approximately 6-7mm. See attached photos for reference. This is informed to ZPMC CWI Qiu Wen and ABF QA Shao Jian Yuan.
