**DEPARTMENT OF TRANSPORTATION**

Contract #: 04-0120F4Cty: SF/ALA Rte: 80 PM: 13.2/13.9File #: 1.28**WELDING INSPECTION REPORT****Resident Engineer:** Siegenthaler, Peter**Address:** 333 Burma Road**City:** Oakland, CA 94607**Report No:** WIR-019464**Date Inspected:** 20-Jan-2011**Project Name:** SAS Superstructure**OSM Arrival Time:** 700**Prime Contractor:** American Bridge/Fluor Enterprises, a JV**OSM Departure Time:** 1530**Contractor:** American Bridge/Fluor Enterprises, a JV**Location:** Job Site**CWI Name:** William Sherwood**CWI Present:** Yes No**Inspected CWI report:** Yes No N/A**Rod Oven in Use:** Yes No N/A**Electrode to specification:** Yes No N/A**Weld Procedures Followed:** Yes No N/A**Qualified Welders:** Yes No N/A**Verified Joint Fit-up:** Yes No N/A**Approved Drawings:** Yes No N/A**Approved WPS:** Yes No N/A**Delayed / Cancelled:** Yes No N/A**Bridge No:** 34-0006**Component:** S.A.S. components**Summary of Items Observed:**

# WELDING INSPECTION REPORT

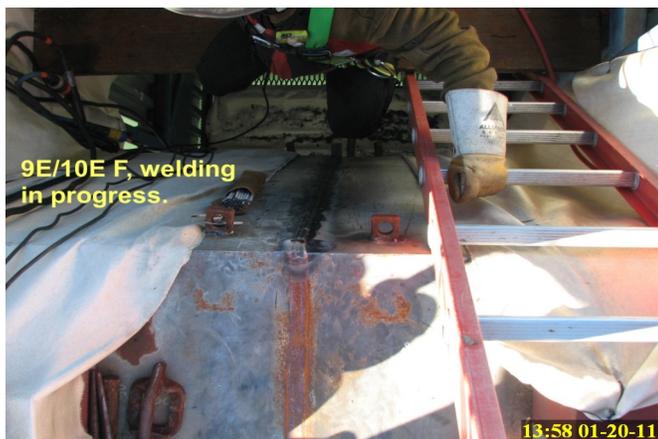
1) The QAI observed ABF personnel welding plate B and plate F at OBG lifts 9E/10E field splice. The QAI noted that the Quality Control (QC) Inspector William Sherwood is monitoring this welding. At weld B, the QAI observed ABF worker Xiao Jian Wan, ID 9677, making the vertical (3G) complete joint penetration (CJP) weld using shielded metal arc welding (SMAW) with E7018-H4R electrodes. At weld F, the QAI observed ABF worker Hua Qiang Hwang, ID 2930, making the 3G CJP weld using SMAW with E7018-H4R electrodes. The QAI was informed that welding procedure specification ABF-WPS-D15-1040A is being used for this welding. The QAI randomly measured the preheat, interpass temperature and welding parameters and noted that they appeared to be conforming to the WPS requirements. See the attached photo.

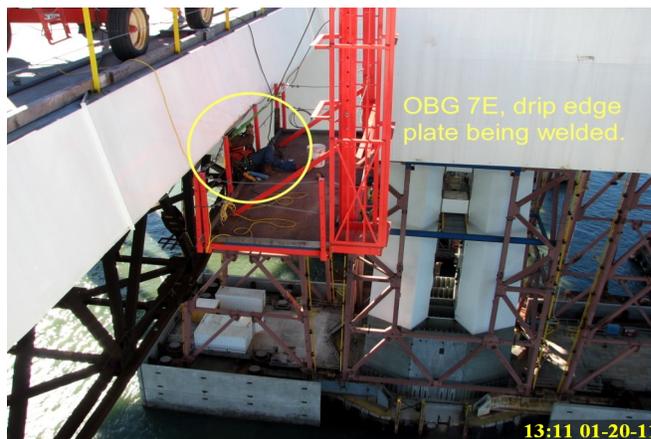
2) The QAI observed ABF personnel welding drip edge plate onto OBG lift 7E at approximately panel point (P.P.) 54, line E5. The QAI noted that the welding includes 3G and overhead position (4F) fillet welding to install the drip edge plates. The QAI noted that the QC Inspector William Sherwood is monitoring this welding. The QAI observed ABF worker Eric Sparks, ID 3040, making the welds using SMAW with E7018-H4R electrodes. The

QAI was informed that ABF-WPS-D15-F1200A and ABF-WPS-D15-1040A are being used for this welding. The QAI randomly measured the interpass temperature and welding parameters and noted that they appeared to be conforming to the WPS requirements. See the attached photo.
