Quality Assurance and Source Inspection

Contract #: 04-0120F4Cty: SF/ALA Rte: 80 PM: 13.2/13.9File #: 99.28**WELDING INSPECTION REPORT****Resident Engineer:** Siegenthaler, Peter**Address:** 333 Burma Road**City:** Oakland, CA 94607**Report No:** WIR-019597**Date Inspected:** 21-Nov-2010**Project Name:** SAS Superstructure**OSM Arrival Time:** 1900**Prime Contractor:** American Bridge/Fluor Enterprises, a JV**OSM Departure Time:** 700**Contractor:** Zhenhua Port Machinery Company, Ltd (ZPMC), Changxing Island **Location:** Shanghai China**CWI Name:** See Below**CWI Present:** Yes No**Inspected CWI report:** Yes No N/A**Rod Oven in Use:** Yes No N/A**Electrode to specification:** Yes No N/A**Weld Procedures Followed:** Yes No N/A**Qualified Welders:** Yes No N/A**Verified Joint Fit-up:** Yes No N/A**Approved Drawings:** Yes No N/A**Approved WPS:** Yes No N/A**Delayed / Cancelled:** Yes No N/A**Bridge No:** 34-0006**Component:** OBG**Summary of Items Observed:**

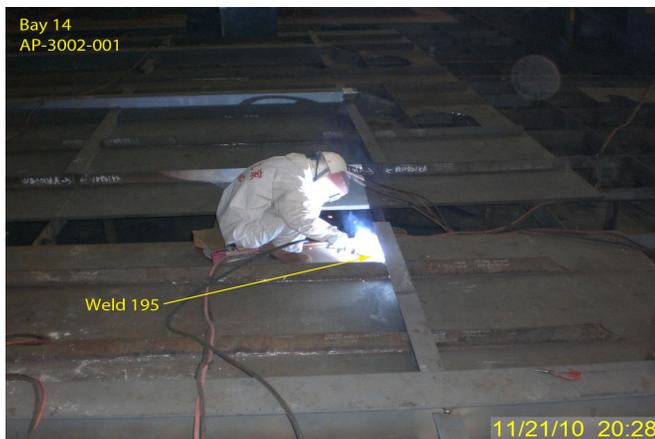
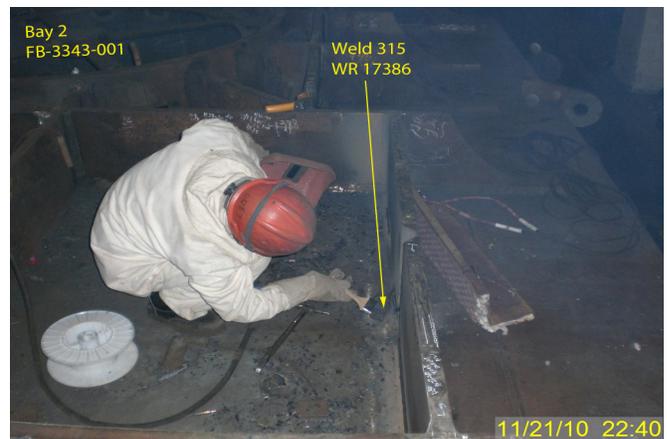
Unless otherwise noted, all work observed on this date appeared to be in general compliance with the applicable contract documents.
