DEPARTMENT OF TRANSPORTATION

Quality Assurance and Source Inspection

Contract #: 04-0120F4Cty: SF/ALA Rte: 80 PM: 13.2/13.9File #: 99.28**WELDING INSPECTION REPORT****Resident Engineer:** Siegenthaler, Peter**Address:** 333 Burma Road**City:** Oakland, CA 94607**Report No:** WIR-019655**Date Inspected:** 20-Jan-2011**Project Name:** SAS Superstructure**OSM Arrival Time:** 700**Prime Contractor:** American Bridge/Fluor Enterprises, a JV**OSM Departure Time:** 1900**Contractor:** Zhenhua Port Machinery Company, Ltd (ZPMC) Chanxing Island**Location:** Shanghai, China**CWI Name:** Mr. LIU HUA JIE**CWI Present:** Yes No**Inspected CWI report:** Yes No N/A**Rod Oven in Use:** Yes No N/A**Electrode to specification:** Yes No N/A**Weld Procedures Followed:** Yes No N/A**Qualified Welders:** Yes No N/A**Verified Joint Fit-up:** Yes No N/A**Approved Drawings:** Yes No N/A**Approved WPS:** Yes No N/A**Delayed / Cancelled:** Yes No N/A**Bridge No:** 34-0006**Component:** OBG Segment**Summary of Items Observed:**

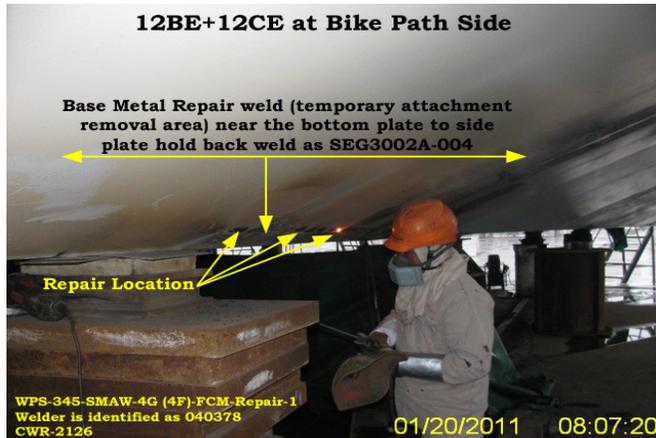
ZPMC welding personnel performing Shielded Metal Arc Welding (SMAW) of Base Metal Repair weld (temporary attachment removal area) near the bottom plate to side plate hold back weld joint located on 12BE+12CE at bike path side. The location near the weld is designated as SEG3002A-004. The welder is identified as 040378. ZPMC QC Mr. LIU HUA JIE was onsite monitoring the welding variables. The inprocess SMAW appears to be progressing in compliance with WPS-345-SMAW-4G (4F)-FCM-Repair-1. The weld repair report number is named as CWR-2126. Further weld detail mention in attached picture
