Contract #: 04-0120F4Cty: SF/ALA Rte: 80 PM: 13.2/13.9File #: xx.28**WELDING INSPECTION REPORT****Resident Engineer:** Siegenthaler, Peter**Address:** 333 Burma Road**City:** Oakland, CA 94607**Report No:** WIR-019679**Date Inspected:** 29-Dec-2010**Project Name:** SAS Superstructure**OSM Arrival Time:** 700**Prime Contractor:** American Bridge/Fluor Enterprises, a JV**OSM Departure Time:** 1900**Contractor:** Zhenhua Port Machinery Company, Ltd (ZPMC), Changxing Island **Location:** SHANGHAI CHINA**CWI Name:** Mr. Li Ming Yang**CWI Present:** Yes No**Inspected CWI report:** Yes No N/A**Rod Oven in Use:** Yes No N/A**Electrode to specification:** Yes No N/A**Weld Procedures Followed:** Yes No N/A**Qualified Welders:** Yes No N/A**Verified Joint Fit-up:** Yes No N/A**Approved Drawings:** Yes No N/A**Approved WPS:** Yes No N/A**Delayed / Cancelled:** Yes No N/A**Bridge No:** 34-0006**Component:** OBG TRIAL ASSEMBLY & bay 14**Summary of Items Observed:**

WELDING INSPECTION REPORT

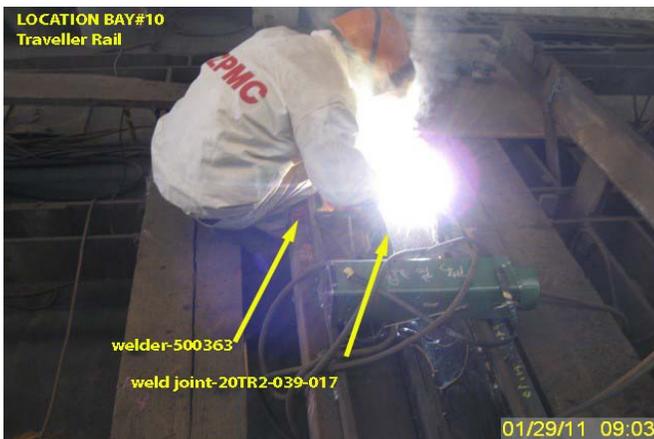
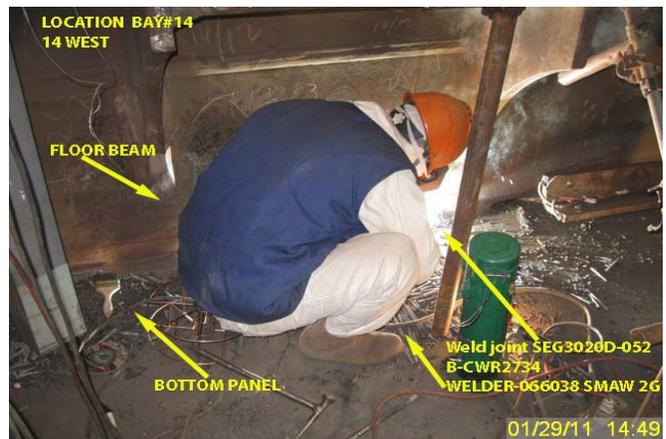
Shielded Metal Arc (SMAW) welding of Weld Joint SEG3020D-052(14W, Bottom plate and floor beam), And Critical Welding Repair Report (CWR) B-CWR2734 Rev.1, and Welder is identified as 066038; ZPMC Quality Control (QC) is identified as Mr. Li Ming Yang. The welding variables appeared to comply with the Applicable WPS-345-SMAW-2G (2F)-FCM-Repair-1.

Shielded Metal Arc (SMAW) welding of Weld Joint SEG3020E-056(14W, Bottom plate and floor beam), And Critical Welding Repair Report (CWR) B-CWR2734 Rev.1, and Welder is identified as 066398; ZPMC Quality Control (QC) is identified as Mr. Li Ming Yang. The welding variables appeared to comply with the Applicable WPS-345-SMAW-2G (2F)-FCM-Repair-1.

Flux Cored Arc (FCAW) welding of Weld Joint SEG3014D-004(13CW Deck plate diaphragm to floor beam weld), And Welder is identified as 066734; ZPMC Quality Control (QC) is identified as Mr. Cao Hai Zhou . The

Shielded Metal Arc (SMAW) welding of Weld Joint 20TR2-039-017(Traveller Rail), And UT Report number B787-UT-17902,and ZPMC produce Temporary Welding Repair Report(WR), Welder is identified as 500363; ZPMC Quality Control (QC) is identified as Mr. Zhao Chen Sun . The welding variables appeared to comply with the Applicable WPS-345-SMAW-1G(1F)-Repair.

Flux Cored Arc (FCAW) welding of Weld Joint 20TR2-039-015(Traveller Rail), And UT Report number B787-UT-17902,and ZPMC produce Temporary Welding Repair Report(WR), Welder is identified as 040434; ZPMC Quality Control (QC) is identified as Mr. Zhao Chen Sun . The welding variables appeared to comply with the Applicable WPS-345-SMAW-1G(1F)-Repair.
