**DEPARTMENT OF TRANSPORTATION**

Quality Assurance and Source Inspection

Contract #: 04-0120F4Cty: SF/ALA Rte: 80 PM: 13.2/13.9File #: xx.28**WELDING INSPECTION REPORT****Resident Engineer:** Siegenthaler, Peter**Address:** 333 Burma Road**City:** Oakland, CA 94607**Report No:** WIR-019936**Date Inspected:** 20-Sep-2010**Project Name:** SAS Superstructure**OSM Arrival Time:** 700**Prime Contractor:** American Bridge/Fluor Enterprises, a JV**OSM Departure Time:** 1900**Contractor:** Zhenhua Port Machinery Company, Ltd (ZPMC), Changxing Island **Location:** Shanghai China**CWI Name:** Mr. Xu Le Feng.**CWI Present:** Yes No**Inspected CWI report:** Yes No N/A**Rod Oven in Use:** Yes No N/A**Electrode to specification:** Yes No N/A**Weld Procedures Followed:** Yes No N/A**Qualified Welders:** Yes No N/A**Verified Joint Fit-up:** Yes No N/A**Approved Drawings:** Yes No N/A**Approved WPS:** Yes No N/A**Delayed / Cancelled:** Yes No N/A**Bridge No:** 34-0006**Component:** Tower BAY 10, 11 & jetty**Summary of Items Observed:**

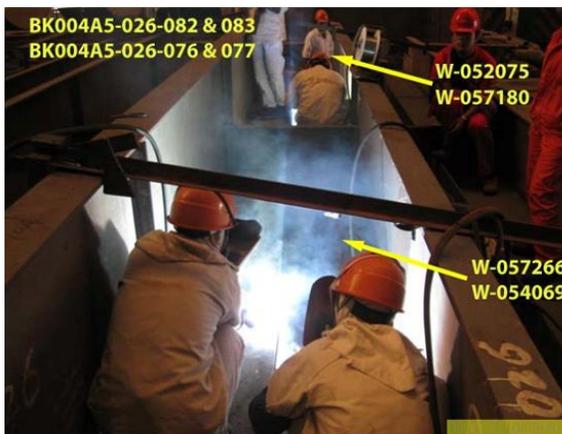
This QA Inspector performed VT of 100% of the area previously tested and accepted by ZPMC Quality Control personnel. The member is identified as North Tower Lift 5 welds. The weld designations reviewed are as follows.

1.NSD1-TL5-3B/F-16A/B,17A/B,21A/B,23A/B.

Unless otherwise noted, all work observed on this date appeared to be in general compliance with the applicable contract documents.
