**DEPARTMENT OF TRANSPORTATION**

Contract #: 04-0120F4Cty: SF/ALA Rte: 80 PM: 13.2/13.9File #: xx.28**WELDING INSPECTION REPORT****Resident Engineer:** Siegenthaler, Peter**Address:** 333 Burma Road**City:** Oakland, CA 94607**Report No:** WIR-020003**Date Inspected:** 04-Dec-2010**Project Name:** SAS Superstructure**OSM Arrival Time:** 700**Prime Contractor:** American Bridge/Fluor Enterprises, a JV**OSM Departure Time:** 1900**Contractor:** Zhenhua Port Machinery Company, Ltd (ZPMC), Changxing Island **Location:** SHANGHAI CHINA**CWI Name:** Mr. An Qing Xing.**CWI Present:** Yes No**Inspected CWI report:** Yes No N/A**Rod Oven in Use:** Yes No N/A**Electrode to specification:** Yes No N/A**Weld Procedures Followed:** Yes No N/A**Qualified Welders:** Yes No N/A**Verified Joint Fit-up:** Yes No N/A**Approved Drawings:** Yes No N/A**Approved WPS:** Yes No N/A**Delayed / Cancelled:** Yes No N/A**Bridge No:** 34-0006**Component:** OBG TRIAL ASSEMBLY**Summary of Items Observed:**

# WELDING INSPECTION REPORT

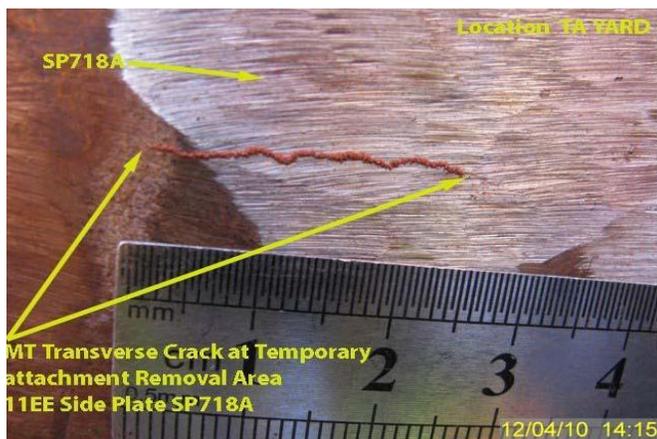
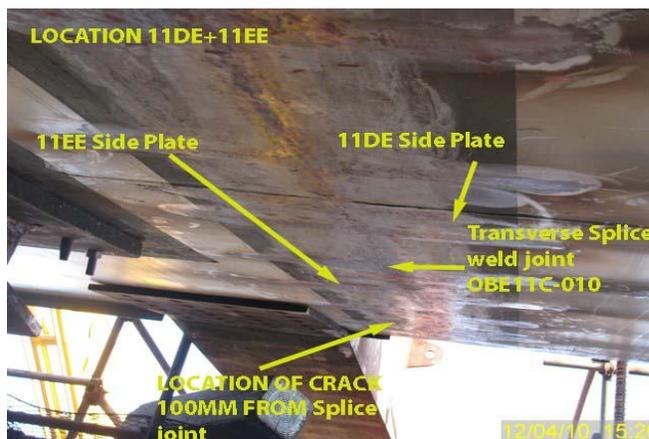
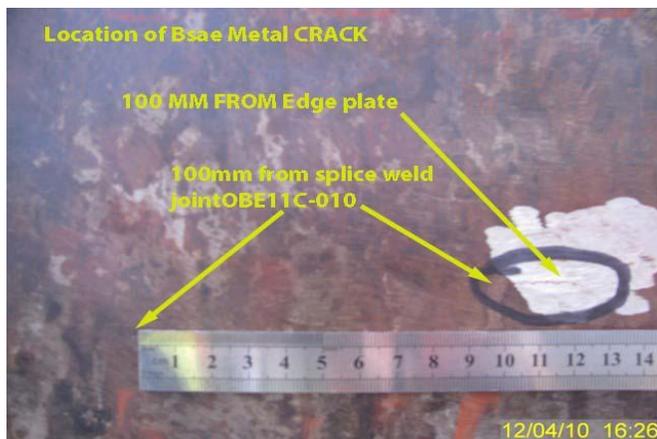
This QA Inspector performed MT of approximately 15% of the area previously tested and accepted by ZPMC Quality Control personnel. This QA Inspector generated a MT report for this date. The member is identified as OBG 11DE+11EE Transverse splice joint & Temporary attachments Removal area welds. The weld designations reviewed are as follows.

1. OBE11C-006~010(Transverse splice joint weld)
2. OBE11C-006~009(Temporary attachment Removal area)
3. OBE11C-010(Temporary attachment Removal area) found rejected and Incident Report generated for this weld joint,
