DEPARTMENT OF TRANSPORTATION

Quality Assurance and Source Inspection

Contract #: 04-0120F4Cty: SF/ALA Rte: 80 PM: 13.2/13.9File #: 69.28**WELDING INSPECTION REPORT****Resident Engineer:** Pursell, Gary**Address:** 333 Burma Road**City:** Oakland, CA 94607**Report No:** WIR-020058**Date Inspected:** 17-Mar-2010**Project Name:** SAS Superstructure**OSM Arrival Time:** 700**Prime Contractor:** American Bridge/Fluor Enterprises, a JV**OSM Departure Time:** 1900**Contractor:** Zhenhua Port Machinery Company, Ltd (ZPMC), Changxing Island **Location:** Shanghai, China

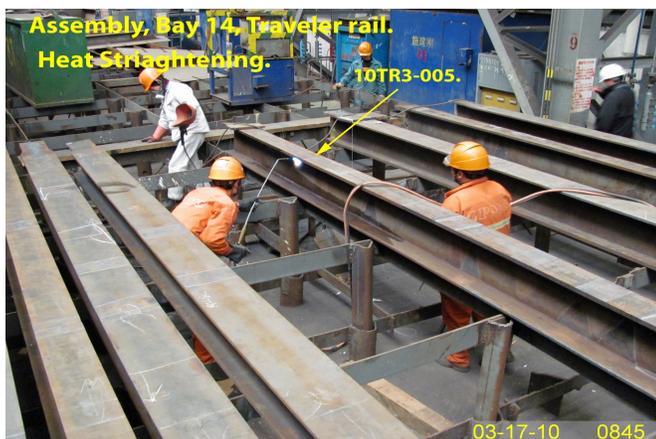
Assembly, Bay 14, Traveler rail.

During Random Visual in process Inspection, this QA inspector observed Heat Straightening of Traveler rail 10TR3-005. The attached photographs provide additional detail.

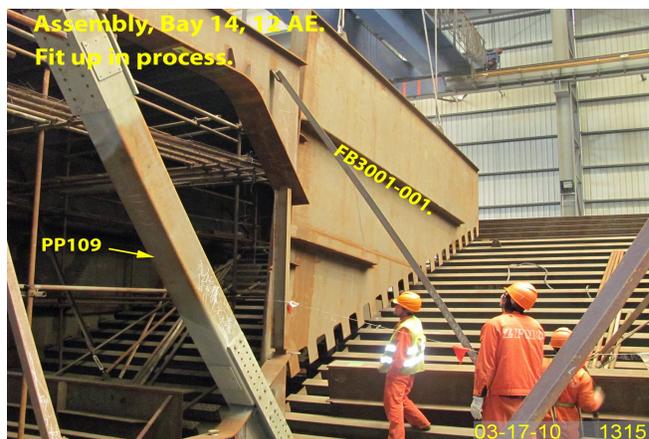
Assembly, Bay 14, 12AE, PP109.

During the Quality Assurance (QA) random in-process visual inspection, this QA inspector ZPMC Personnel performing fit up of Floor Beam Identified as FB3001-001. The attached photographs provide additional detail.
