**DEPARTMENT OF TRANSPORTATION**

Contract #: 04-0120F4Cty: SF/ALA Rte: 80 PM: 13.2/13.9File #: 99.28**WELDING INSPECTION REPORT****Resident Engineer:** Siegenthaler, Peter**Address:** 333 Burma Road**City:** Oakland, CA 94607**Report No:** WIR-020070**Date Inspected:** 01-Feb-2011**Project Name:** SAS Superstructure**OSM Arrival Time:** 700**Prime Contractor:** American Bridge/Fluor Enterprises, a JV**OSM Departure Time:** 1900**Contractor:** Zhenhua Port Machinery Company, Ltd (ZPMC) Chanxing Island **Location:** Shanghai, China**CWI Name:** Mr. Qui Wen**CWI Present:** Yes No**Inspected CWI report:** Yes No N/A**Rod Oven in Use:** Yes No N/A**Electrode to specification:** Yes No N/A**Weld Procedures Followed:** Yes No N/A**Qualified Welders:** Yes No N/A**Verified Joint Fit-up:** Yes No N/A**Approved Drawings:** Yes No N/A**Approved WPS:** Yes No N/A**Delayed / Cancelled:** Yes No N/A**Bridge No:** 34-0006**Component:** OBG Segment**Summary of Items Observed:**

## WELDING INSPECTION REPORT

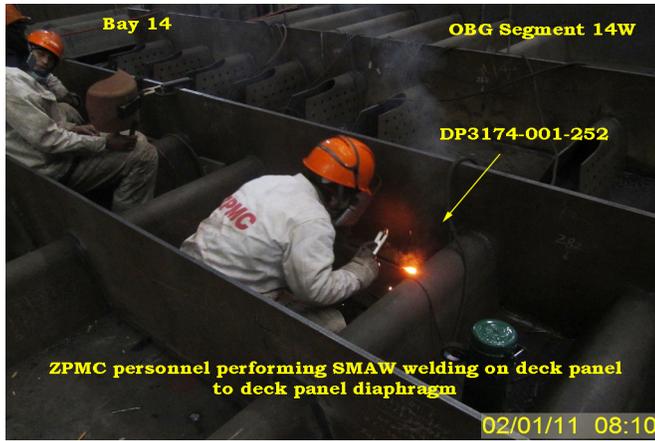
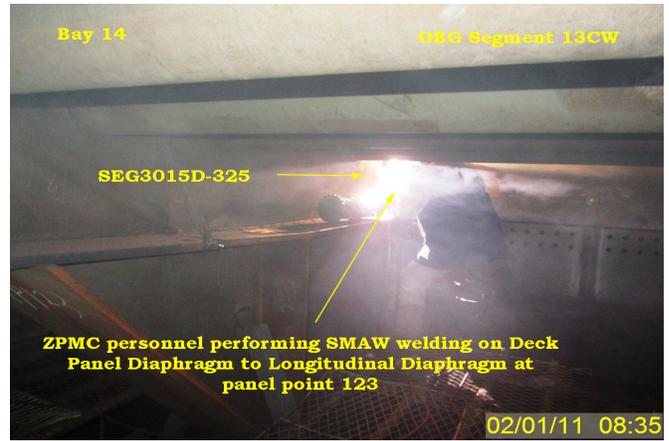
SMAW welding of weld joint SEG3015D-325 located on Deck Panel Diaphragm to Longitudinal Diaphragm at panel point 123 of OBG Segment 13CW. ZPMC Welder is identified as 066674. ZPMC Quality Control (QC) is identified as Mr. Qui Wen. The welding variables recorded by QC appeared to comply with the Applicable WPS-B-P-2213-Tc-U4b-FCM-1.

See the attached picture.
