DEPARTMENT OF TRANSPORTATION

Contract #: 04-0120F4Cty: SF/ALA Rte: 80 PM: 13.2/13.9File #: 69.28**WELDING INSPECTION REPORT****Resident Engineer:** Siegenthaler, Peter**Address:** 333 Burma Road**City:** Oakland, CA 94607**Report No:** WIR-020304**Date Inspected:** 17-Jan-2011**Project Name:** SAS Superstructure**OSM Arrival Time:** 1900**Prime Contractor:** American Bridge/Fluor Enterprises, a JV**OSM Departure Time:** 700**Contractor:** Zhenhua Port Machinery Company, Ltd (ZPMC), Changxing Island **Location:** Shanghai, China**CWI Name:** See below**CWI Present:** Yes No**Inspected CWI report:** Yes No N/A**Rod Oven in Use:** Yes No N/A**Electrode to specification:** Yes No N/A**Weld Procedures Followed:** Yes No N/A**Qualified Welders:** Yes No N/A**Verified Joint Fit-up:** Yes No N/A**Approved Drawings:** Yes No N/A**Approved WPS:** Yes No N/A**Delayed / Cancelled:** Yes No N/A**Bridge No:** 34-0006**Component:** OBG**Summary of Items Observed:**

WELDING INSPECTION REPORT

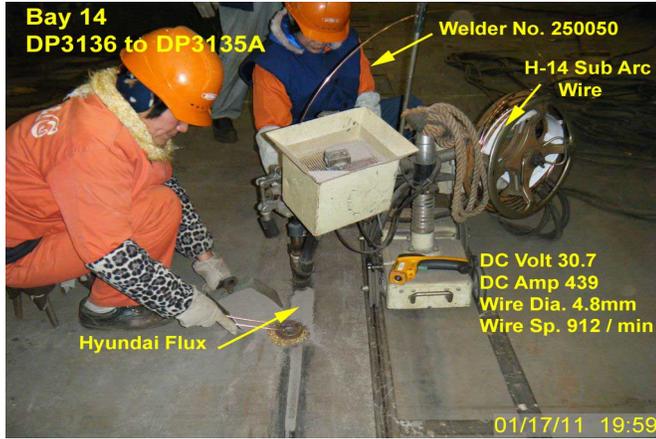
ZPMC was using the Submerged Arc Welding (SAW) process.

Components; OBG DP3136 to DP3135A (see photo below)

PCMK: SEG3014

Weld No: 003

Welders: 250050

WPS-B-T-2221-B-L2C-S-2
