Quality Assurance and Source Inspection

Contract #: 04-0120F4Cty: SF/ALA Rte: 80 PM: 13.2/13.9File #: 69.28**WELDING INSPECTION REPORT****Resident Engineer:** Siegenthaler, Peter**Address:** 333 Burma Road**City:** Oakland, CA 94607**Report No:** WIR-020460**Date Inspected:** 06-Feb-2011**Project Name:** SAS Superstructure**OSM Arrival Time:** 700**Prime Contractor:** American Bridge/Fluor Enterprises, a JV**OSM Departure Time:** 1900**Contractor:** Zhenhua Port Machinery Company, Ltd (ZPMC), Changxing Island **Location:** Shanghai, China**CWI Name:** Qiu Wen**CWI Present:** Yes No**Inspected CWI report:** Yes No N/A**Rod Oven in Use:** Yes No N/A**Electrode to specification:** Yes No N/A**Weld Procedures Followed:** Yes No N/A**Qualified Welders:** Yes No N/A**Verified Joint Fit-up:** Yes No N/A**Approved Drawings:** Yes No N/A**Approved WPS:** Yes No N/A**Delayed / Cancelled:** Yes No N/A**Bridge No:** 34-0006**Component:** Orthotropic Box Girder (OBG)**Summary of Items Observed:**

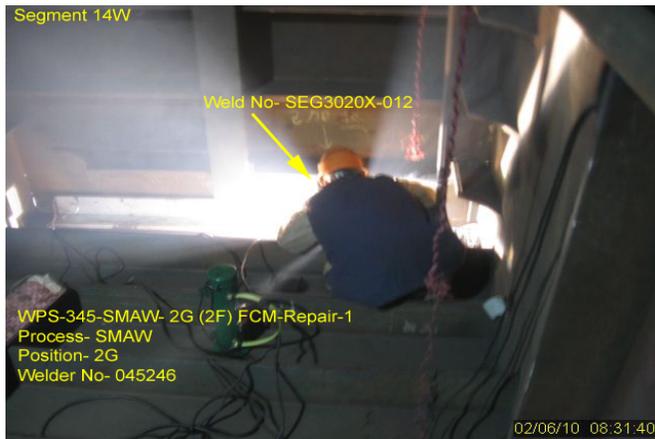
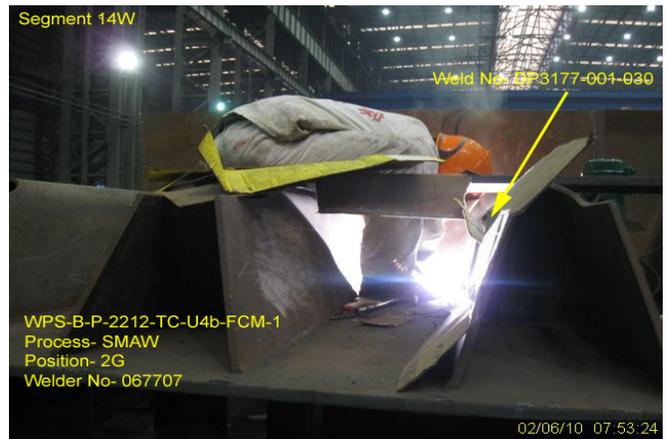
This QA Inspector observed ZPMC qualified welding personnel identified as 045246 perform Shielded Metal Arc Welding (SMAW), weld joint identified as SEG3020X-012; located On Orthotropic Box Girder (OBG) Bottom Plate to Floor Beam CJP Weld; ABF Quality Assurance (QA) is identified as Mr. Wang Jiang Hua. The Critical Welding Repair Report (CWRR) was B-CWR2659 Rev- 2. This QA Inspector observed a welding current of approximately 238 amps and 25.4 volts and the base material appears to have been being preheated by an electrical heating elements prior to welding. ABF Quality Assurance (QA) Mr. Wang Jiang Hua was onsite monitoring the welding variables. The welding variables recorded by QA appeared to comply with applicable WPS-345-SMAW-2G (2F) FCM-Repair-1. See attached photo for further details.
