**DEPARTMENT OF TRANSPORTATION**

Contract #: 04-0120F4Cty: SF/ALA Rte: 80 PM: 13.2/13.9File #: 99.28**WELDING INSPECTION REPORT****Resident Engineer:** Siegenthaler, Peter**Address:** 333 Burma Road**City:** Oakland, CA 94607**Report No:** WIR-020520**Date Inspected:** 11-Dec-2010**Project Name:** SAS Superstructure**OSM Arrival Time:** 700**Prime Contractor:** American Bridge/Fluor Enterprises, a JV**OSM Departure Time:** 1900**Contractor:** Zhenhua Port Machinery Company, Ltd (ZPMC) Chanxing Island**Location:** Shanghai, China**CWI Name:** Mr. AN QING XING**CWI Present:** Yes No**Inspected CWI report:** Yes No N/A**Rod Oven in Use:** Yes No N/A**Electrode to specification:** Yes No N/A**Weld Procedures Followed:** Yes No N/A**Qualified Welders:** Yes No N/A**Verified Joint Fit-up:** Yes No N/A**Approved Drawings:** Yes No N/A**Approved WPS:** Yes No N/A**Delayed / Cancelled:** Yes No N/A**Bridge No:** 34-0006**Component:** OBG Segment**Summary of Items Observed:**

# WELDING INSPECTION REPORT

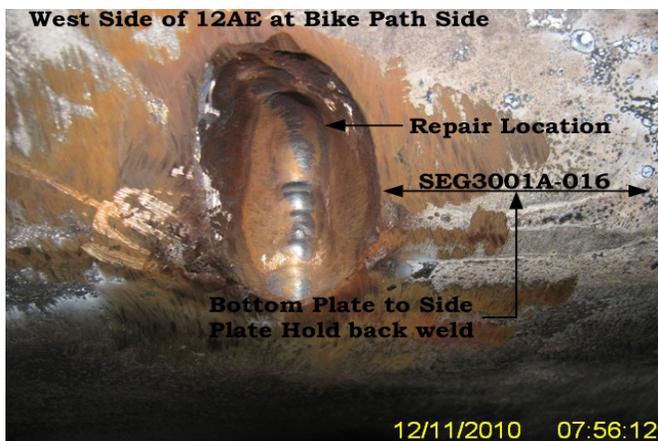
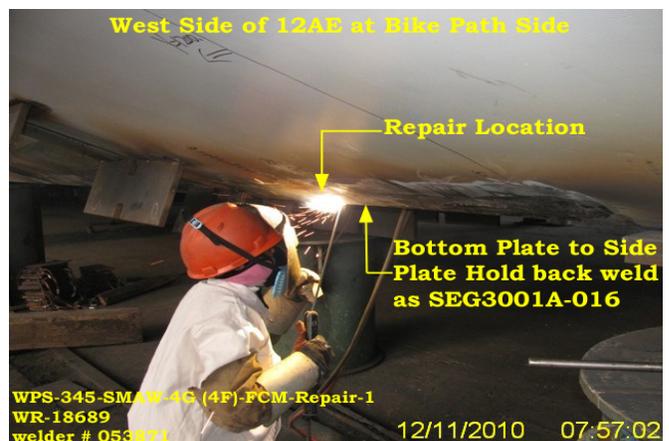
ZPMC welding personnel performing Shielded Metal Arc Welding (SMAW) of Repair weld for the bottom plate to side plate hold back weld joint located on west side of 12AE at bike path side. The weld is designated as SEG3001A-016. The welder is identified as 053871. ZPMC QC Mr. WANG LI YANG was onsite monitoring the welding variables. The inprocess SMAW appears to be progressing in compliance with WPS-345-SMAW-4G (4F)-FCM-Repair-1. The weld repair report number is named as WR-18689. Further weld detail mention in attached picture.
