Contract #: 04-0120F4Cty: SF/ALA Rte: 80 PM: 13.2/13.9File #: 69.28**WELDING INSPECTION REPORT****Resident Engineer:** Siegenthaler, Peter**Address:** 333 Burma Road**City:** Oakland, CA 94607**Report No:** WIR-020617**Date Inspected:** 10-Dec-2010**Project Name:** SAS Superstructure**OSM Arrival Time:** 700**Prime Contractor:** American Bridge/Fluor Enterprises, a JV**OSM Departure Time:** 1900**Contractor:** Zhenhua Port Machinery Company, Ltd (ZPMC), Changxing Island **Location:** Shanghai, China

Bridge No: 34-0006**Component:** BAY 14 OBG**Summary of Items Observed:**

OBG BAY 14

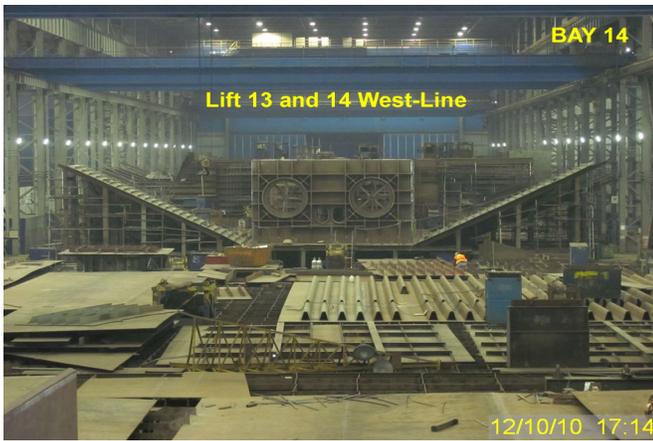
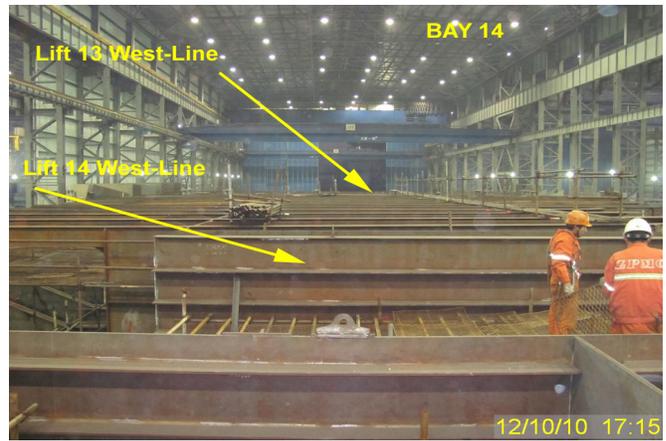
SAW welding of complete joint penetration weld joint(s) located on Deck Plates identified as Segment 3020* DP3173 to 3174 weld number(s) 007. Welder is identified as welder no. 045265. The welding variables recorded by ZPMC QC identified as Mr. Shao Jian Yuan appeared to comply with applicable WPS(s) WPS-B-T-2221-B-L2C-S-2.

SMAW welding of complete joint penetration weld joint(s) located on Segment 3019A-019 Bottom Panel to side Panel weld number(s) 020. Welder is identified as welder no (s). 051348. The welding variables recorded by ZPMC QC identified as Sun Tian Liang appeared to comply with applicable WPS(s) WPS-B-P-2214-TC-U4b-FCM 1.

During random in process inspection of Orthotropic Box Girder (OBG) member identified as DP3104-001 weld number(s) 251 this QA Inspector observed weld repair of complete joint penetration weld joint(s). ZPMC Quality Control personnel previously tested and rejected portions of this weld.

FCAW welding of complete joint penetration weld joint(s) located on Diaphragm Plate to Deck Plate identified as noted above. Welder is identified as welder no. 201087. The welding variables recorded by ZPMC QC identified as Zong Guo Hui appeared to comply with applicable WPS(s) WPS-B-T-2232-ESAB and BCWR2401.
