DEPARTMENT OF TRANSPORTATION

Quality Assurance and Source Inspection

Contract #: 04-0120F4Cty: SF/ALA Rte: 80 PM: 13.2/13.9File #: 69.28**WELDING INSPECTION REPORT****Resident Engineer:** Siegenthaler, Peter**Address:** 333 Burma Road**City:** Oakland, CA 94607**Report No:** WIR-020725**Date Inspected:** 16-Feb-2011**Project Name:** SAS Superstructure**OSM Arrival Time:** 700**Prime Contractor:** American Bridge/Fluor Enterprises, a JV**OSM Departure Time:** 1900**Contractor:** Zhenhua Port Machinery Company, Ltd (ZPMC), Changxing Island **Location:** Shanghai, China**CWI Name:** Li Yan Hua**CWI Present:** Yes No**Inspected CWI report:** Yes No N/A**Rod Oven in Use:** Yes No N/A**Electrode to specification:** Yes No N/A**Weld Procedures Followed:** Yes No N/A**Qualified Welders:** Yes No N/A**Verified Joint Fit-up:** Yes No N/A**Approved Drawings:** Yes No N/A**Approved WPS:** Yes No N/A**Delayed / Cancelled:** Yes No N/A**Bridge No:** 34-0006**Component:** OBG**Summary of Items Observed:**

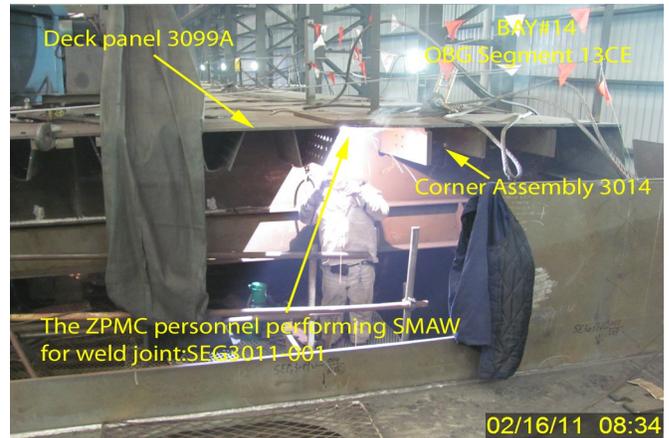
SMAW in the 4G position for the OBG Segment 13CE Deck panel to Corner Assembly. The weld joint was designated as: SEG3011-001. The welder is identified as #067572. ZPMC QC is identified as Mr. Zhong Yong Hong. The welding variables recorded by QC appear to comply with WPS-B-P-2214-B-U2-FCM-1. Please see the attached picture.
