Contract #: 04-0120F4Cty: SF/ALA Rte: 80 PM: 13.2/13.9File #: 69.28**WELDING INSPECTION REPORT****Resident Engineer:** Siegenthaler, Peter**Address:** 333 Burma Road**City:** Oakland, CA 94607**Report No:** WIR-020801**Date Inspected:** 16-Feb-2011**Project Name:** SAS Superstructure**OSM Arrival Time:** 700**Prime Contractor:** American Bridge/Fluor Enterprises, a JV**OSM Departure Time:** 1900**Contractor:** Zhenhua Port Machinery Company, Ltd (ZPMC), Changxing Island **Location:** Shanghai, China**CWI Name:** Zhou Zhong Hai**CWI Present:** Yes No**Inspected CWI report:** Yes No N/A**Rod Oven in Use:** Yes No N/A**Electrode to specification:** Yes No N/A**Weld Procedures Followed:** Yes No N/A**Qualified Welders:** Yes No N/A**Verified Joint Fit-up:** Yes No N/A**Approved Drawings:** Yes No N/A**Approved WPS:** Yes No N/A**Delayed / Cancelled:** Yes No N/A**Bridge No:** 34-0006**Component:** OBG Segments**Summary of Items Observed:**

On this date Caltrans OSM Quality Assurance (QA) Inspector, Dan Hernandez was present during the times noted above to observe the fit up, welding and related activities associated with the fabrication of the San Francisco Oakland Bay Self Anchored S

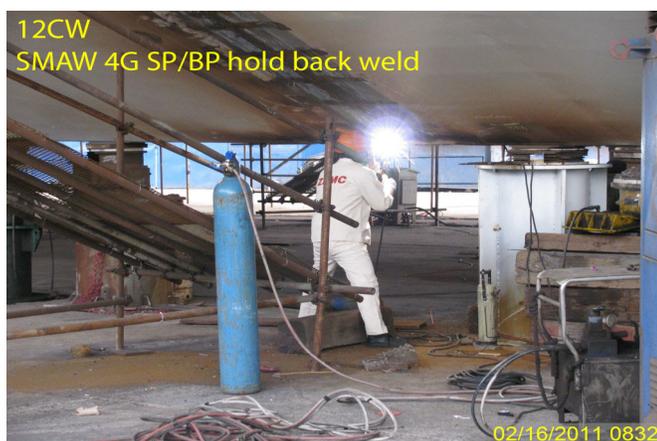
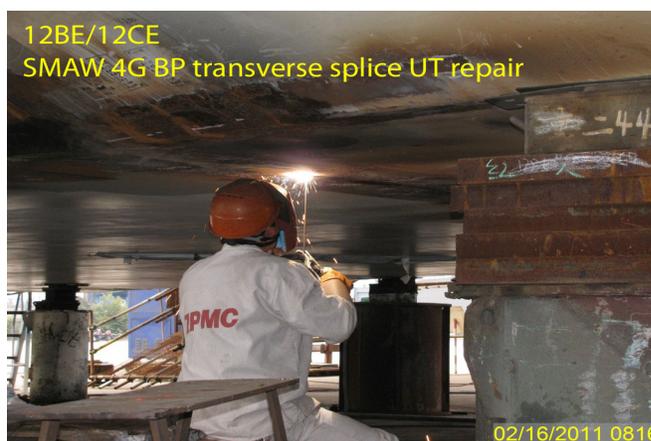
This QA Inspector observed Shielded Metal Arc Welding (SMAW) in progress of a UT repair on a Complete Joint Penetration (CJP) weld joint. The Weld joint is designated OBE12C-001, Bottom Plate transverse splice. The welder is identified as #040320 and was observed welding in the 4G (overhead) position using approved Welding Procedure Specification WPS-345-SMAW-4G (4F)-FCM-repair-1 for WR20190.

This QA Inspector observed Shielded Metal Arc Welding (SMAW) in progress of Complete Joint Penetration (CJP) weld joint. The Weld joint is designated SEG3006A-011, Bottom Plate to Side Plate hold back weld. The welder is identified as #057333 and was observed welding in the 4G (overhead) position using approved Welding Procedure Specification WPS-B-P-2214-B-U2-FCM-1.

This QA Inspector observed Shielded Metal Arc Welding (SMAW) in progress of Complete Joint Penetration (CJP) weld joint. The Weld joint is designated SEG3006A-012, Bottom Plate to Side Plate hold back weld. The welder is identified as #040656 and was observed welding in the 4G (overhead) position using approved Welding Procedure Specification WPS-B-P-2214-B-U2-FCM-1.
