Contract #: 04-0120F4Cty: SF/ALA Rte: 80 PM: 13.2/13.9File #: 82.28**WELDING INSPECTION REPORT****Resident Engineer:** Siegenthaler, Peter**Address:** 333 Burma Road**City:** Oakland, CA 94607**Report No:** WIR-020844**Date Inspected:** 05-Feb-2011**Project Name:** SAS Superstructure**OSM Arrival Time:** 500**Prime Contractor:** American Bridge/Fluor Enterprises, a JV**OSM Departure Time:** 1330**Contractor:** Westmont Industries**Location:** Santa Fe Springs, CA.**CWI Name:** Ruben Dominguez**CWI Present:** Yes No**Inspected CWI report:** Yes No N/A**Rod Oven in Use:** Yes No N/A**Electrode to specification:** Yes No N/A**Weld Procedures Followed:** Yes No N/A**Qualified Welders:** Yes No N/A**Verified Joint Fit-up:** Yes No N/A**Approved Drawings:** Yes No N/A**Approved WPS:** Yes No N/A**Delayed / Cancelled:** Yes No N/A**Bridge No:** 34-0006**Component:** Travelers**Summary of Items Observed:**

E2/E3-EB Traveler-South

E2/E3-EB Traveler-North

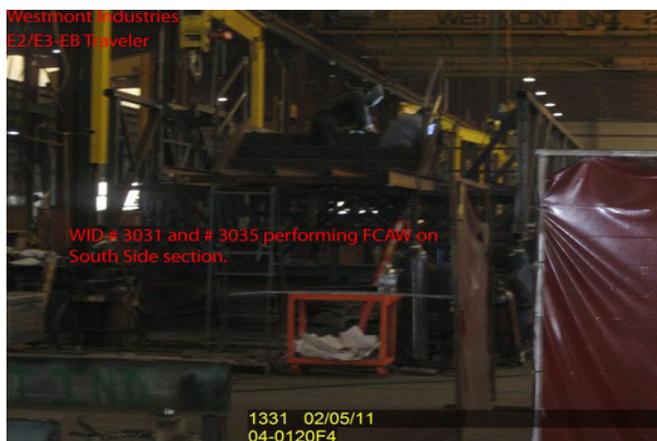
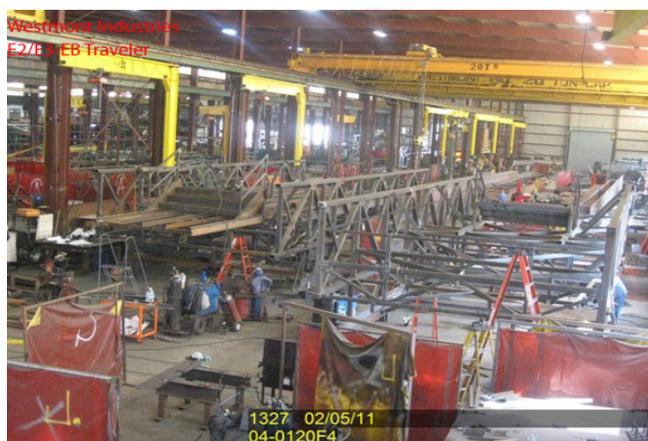
See attached pictures below.

This QA Inspector observed that the activities mentioned above, appeared to be in compliance with the contract requirements and this QA Inspector observed no non-conforming issues, on this date.
