**DEPARTMENT OF TRANSPORTATION**

Contract #: 04-0120F4Cty: SF/ALA Rte: 80 PM: 13.2/13.9File #: 1.28**WELDING INSPECTION REPORT****Resident Engineer:** Siegenthaler, Peter**Address:** 333 Burma Road**City:** Oakland, CA 94607**Report No:** WIR-020850**Date Inspected:** 15-Feb-2011**Project Name:** SAS Superstructure**OSM Arrival Time:** 630**Prime Contractor:** American Bridge/Fluor Enterprises, a JV**OSM Departure Time:** 1500**Contractor:** American Bridge/Fluor Enterprises, a JV**Location:** Job Site

**Bridge No:** 34-0006**Component:** Orthotropic Box Girders**Summary of Items Observed:**

## A). Procedure Qualification Record Test

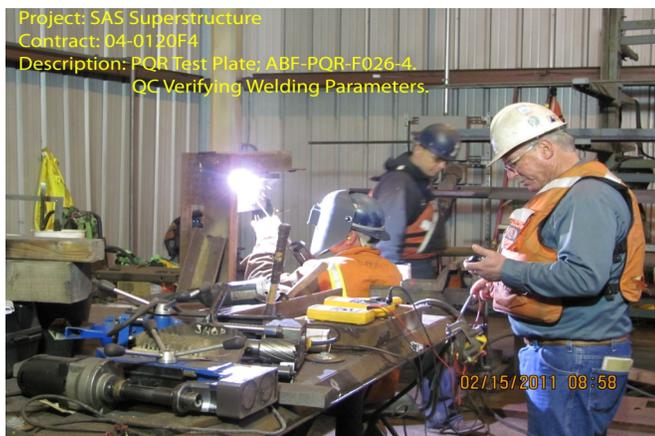
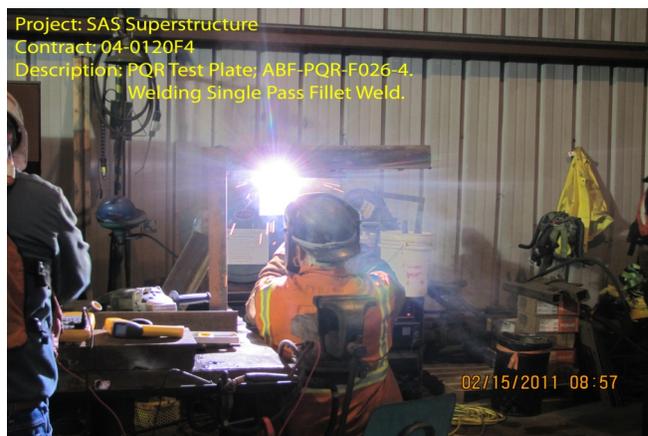
The QAI also observed the welding and inspection of the Procedure Qualification Record (PQR) test plate identified as ABF-PQR-FO26-4, Rev. 0. The welding was performed by Rick Clayborn, ID-2773, utilizing the Shielded Metal Arc Welding process and the 3.2 mm E9018 H4R electrode, as per the PQR which was also utilized by the Quality Control (QC) inspector Mike Johnson as a reference to monitor the welding, to verify the Direct Current (DC) welding parameters and the preheat/interpass temperatures. The welding was performed in the overhead (4F) position with the test plate assembly positioned so that each fillet weld was deposited on the underside of the horizontal surface and against the vertical surface. The maximum single pass fillet weld was

welded on one side of the test plate, and the minimum multiple pass fillet weld was welded on the other side of the test plate. The dimensions of the test coupon were verified as 25 mm thick, 150 mm wide and 300 mm in length. The material specification appeared to comply with the American Society of Testing Materials (ASTM) A709-485 HPS. The welding of the test plate was completed during this shift. For tracking purposes, QAI assigned a lot number identified as B301-002-11A and a TL-6032 was generated on this date.

The digital photographs below illustrate some of the work observed during this scheduled shift.
