DEPARTMENT OF TRANSPORTATION

Quality Assurance and Source Inspection

Contract #: 04-0120F4Cty: SF/ALA Rte: 80 PM: 13.2/13.9File #: 69.28**WELDING INSPECTION REPORT****Resident Engineer:** Siegenthaler, Peter**Address:** 333 Burma Road**City:** Oakland, CA 94607**Report No:** WIR-020912**Date Inspected:** 20-Feb-2011**Project Name:** SAS Superstructure**OSM Arrival Time:** 700**Prime Contractor:** American Bridge/Fluor Enterprises, a JV**OSM Departure Time:** 1900**Contractor:** Zhenhua Port Machinery Company, Ltd (ZPMC), Changxing Island **Location:** Shanghai, China**CWI Name:** Mr. Qiu wen**CWI Present:** Yes No**Inspected CWI report:** Yes No N/A**Rod Oven in Use:** Yes No N/A**Electrode to specification:** Yes No N/A**Weld Procedures Followed:** Yes No N/A**Qualified Welders:** Yes No N/A**Verified Joint Fit-up:** Yes No N/A**Approved Drawings:** Yes No N/A**Approved WPS:** Yes No N/A**Delayed / Cancelled:** Yes No N/A**Bridge No:** 34-0006**Component:** Orthotropic Box Girder (OBG)**Summary of Items Observed:**

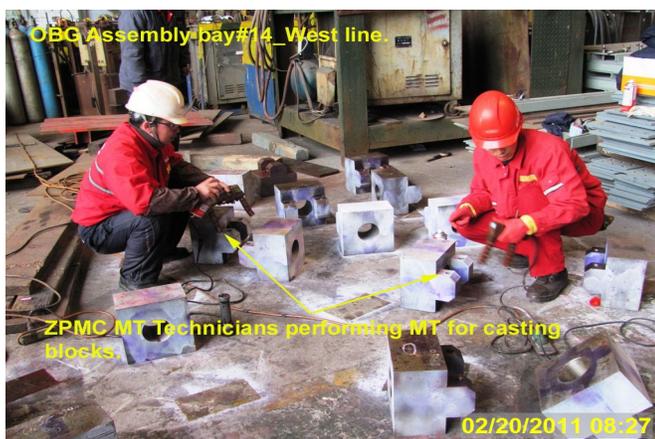
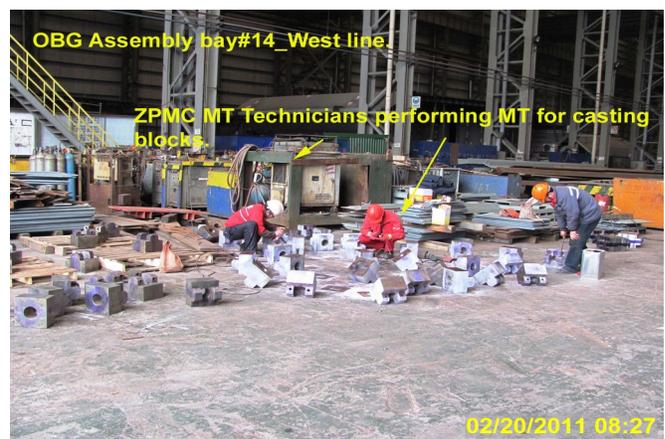
ZPMC MT Technicians performing Magnetic Particle Testing for west line Anchor plate bearing block castings. Refer the attached photos for reference.
