DEPARTMENT OF TRANSPORTATION

Contract #: 04-0120F4Cty: SF/ALA Rte: 80 PM: 13.2/13.9File #: 99.28**WELDING INSPECTION REPORT****Resident Engineer:** Siegenthaler, Peter**Address:** 333 Burma Road**City:** Oakland, CA 94607**Report No:** WIR-021003**Date Inspected:** 17-Feb-2011**Project Name:** SAS Superstructure**OSM Arrival Time:** 700**Prime Contractor:** American Bridge/Fluor Enterprises, a JV**OSM Departure Time:** 1900**Contractor:** Zhenhua Port Machinery Company, Ltd (ZPMC) Chanxing Island**Location:** Shanghai, China**CWI Name:** Mr. Qui Wen**CWI Present:** Yes No**Inspected CWI report:** Yes No N/A**Rod Oven in Use:** Yes No N/A**Electrode to specification:** Yes No N/A**Weld Procedures Followed:** Yes No N/A**Qualified Welders:** Yes No N/A**Verified Joint Fit-up:** Yes No N/A**Approved Drawings:** Yes No N/A**Approved WPS:** Yes No N/A**Delayed / Cancelled:** Yes No N/A**Bridge No:** 34-0006**Component:** OBG Segment**Summary of Items Observed:**

WELDING INSPECTION REPORT

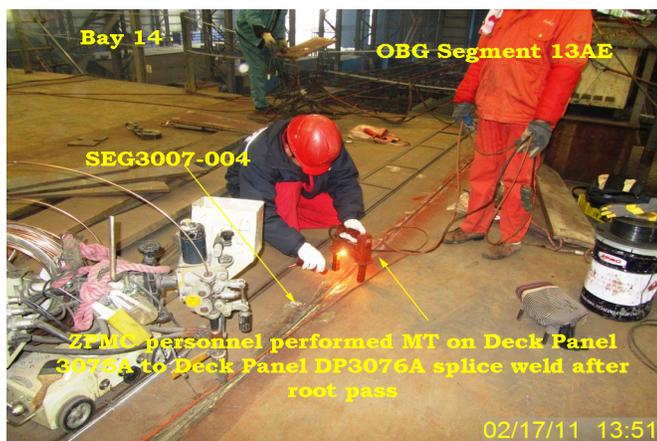
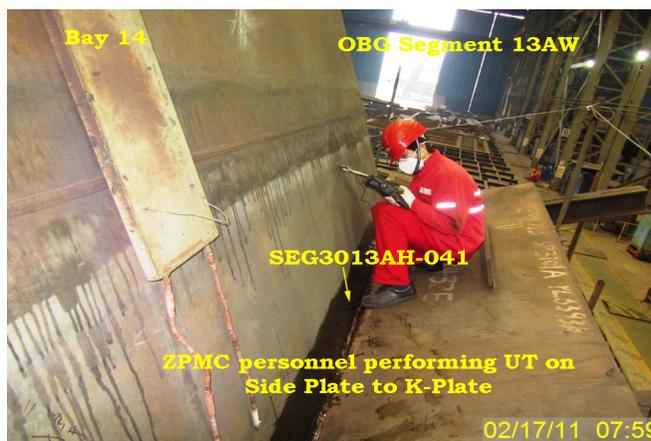
This QA inspector observed ZPMC personnel performed Ultrasonic Testing on OBG Segment 13AW Side Plate to Key Plate 'T' joint. The weld number is identified as SEG3013AH-041. See the attached picture.
