Contract #: 04-0120F4Cty: SF/ALA Rte: 80 PM: 13.2/13.9File #: 69.28**WELDING INSPECTION REPORT****Resident Engineer:** Siegenthaler, Peter**Address:** 333 Burma Road**City:** Oakland, CA 94607**Report No:** WIR-021009**Date Inspected:** 22-Feb-2011**Project Name:** SAS Superstructure**OSM Arrival Time:** 700**Prime Contractor:** American Bridge/Fluor Enterprises, a JV**OSM Departure Time:** 1900**Contractor:** Zhenhua Port Machinery Company, Ltd (ZPMC), Changxing Island **Location:** Shanghai, China**CWI Name:** Cheng Xi/Geng Wei**CWI Present:** Yes No**Inspected CWI report:** Yes No N/A**Rod Oven in Use:** Yes No N/A**Electrode to specification:** Yes No N/A**Weld Procedures Followed:** Yes No N/A**Qualified Welders:** Yes No N/A**Verified Joint Fit-up:** Yes No N/A**Approved Drawings:** Yes No N/A**Approved WPS:** Yes No N/A**Delayed / Cancelled:** Yes No N/A**Bridge No:** 34-0006**Component:** OBG**Summary of Items Observed:**

## WELDING INSPECTION REPORT

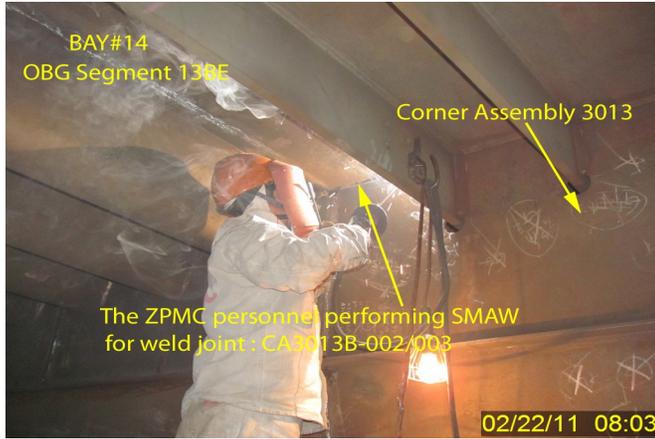
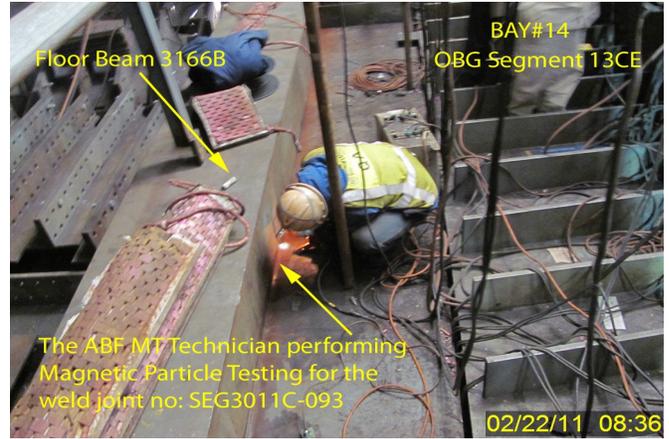
SMAW in the 4F position for the OBG Segment 13BE Corner Assembly. The weld joint was designated as: CA3013B-002/003. The welder is identified as #0067572. ZPMC QC is identified as Mr. Zhong Yong Hong. The welding variables recorded by QC appear to comply with WPS-B-P-2114-FCM-1. Please see the attached picture.
