**DEPARTMENT OF TRANSPORTATION**

Contract #: 04-0120F4Cty: SF/ALA Rte: 80 PM: 13.2/13.9File #: 69.28**WELDING INSPECTION REPORT****Resident Engineer:** Siegenthaler, Peter**Address:** 333 Burma Road**City:** Oakland, CA 94607**Report No:** WIR-021030**Date Inspected:** 26-Feb-2011**Project Name:** SAS Superstructure**OSM Arrival Time:** 700**Prime Contractor:** American Bridge/Fluor Enterprises, a JV**OSM Departure Time:** 1900**Contractor:** Zhenhua Port Machinery Company, Ltd (ZPMC), Changxing Island **Location:** Shanghai, China**CWI Name:** Zhou Zhong Hai**CWI Present:** Yes No**Inspected CWI report:** Yes No N/A**Rod Oven in Use:** Yes No N/A**Electrode to specification:** Yes No N/A**Weld Procedures Followed:** Yes No N/A**Qualified Welders:** Yes No N/A**Verified Joint Fit-up:** Yes No N/A**Approved Drawings:** Yes No N/A**Approved WPS:** Yes No N/A**Delayed / Cancelled:** Yes No N/A**Bridge No:** 34-0006**Component:** OBG COMPONENT**Summary of Items Observed:**

## WELDING INSPECTION REPORT

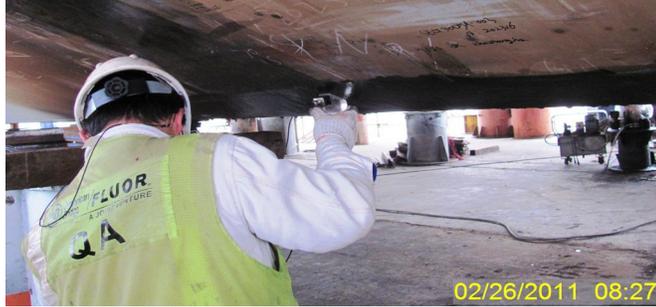
The ABF QA inspector performed D-Scan Ultrasonic Testing for butt joint joining between side plate to bottom plate hold back area at counter weight side on segment 12BW at trial assembly area

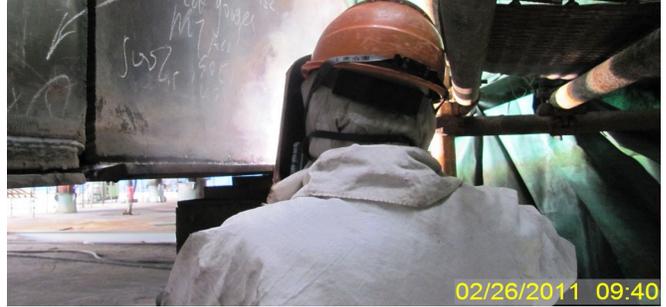
SMAW in the 2G position for the OBG Crossbeam CB17 Weld No. CB3001-017-006. The welder is identified as #067752. ZPMC QC is identified as Mr. Li Yang. The welding variables recorded by QC appear to comply with WPS-B-P-2212-Tc-U4b-FCM-1.The welding variables were recorded at, Amperage 165, volts 25.1.The In-process SMAW appears to be progressing in compliance with approved contract documents.

ZPMC personnel performing SMAW for holdback weld joint CB3001-017-006 at 2G position on side plate to bottom plate of Crossbeam CB17 at Trial Assembly area
