DEPARTMENT OF TRANSPORTATION

Contract #: 04-0120F4Cty: SF/ALA Rte: 80 PM: 13.2/13.9File #: 1.28**WELDING INSPECTION REPORT****Resident Engineer:** Siegenthaler, Peter**Address:** 333 Burma Road**City:** Oakland, CA 94607**Report No:** WIR-021074**Date Inspected:** 25-Mar-2011**Project Name:** SAS Superstructure**OSM Arrival Time:** 630**Prime Contractor:** American Bridge/Fluor Enterprises, a JV**OSM Departure Time:** 1500**Contractor:** American Bridge/Fluor Enterprises, a JV**Location:** Job Site

Bridge No: 34-0006**Component:** Orthotropic Box Girders**Summary of Items Observed:**

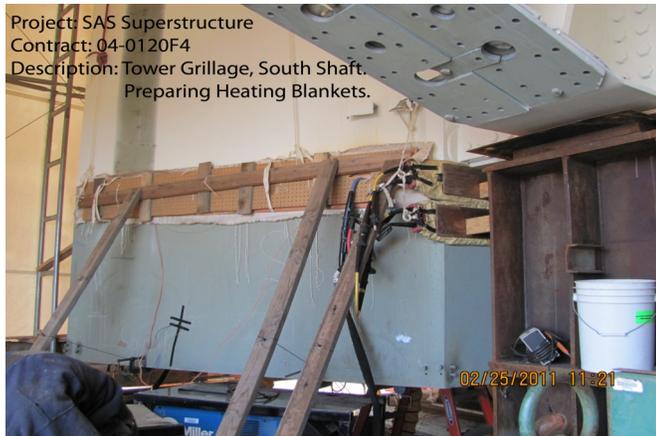
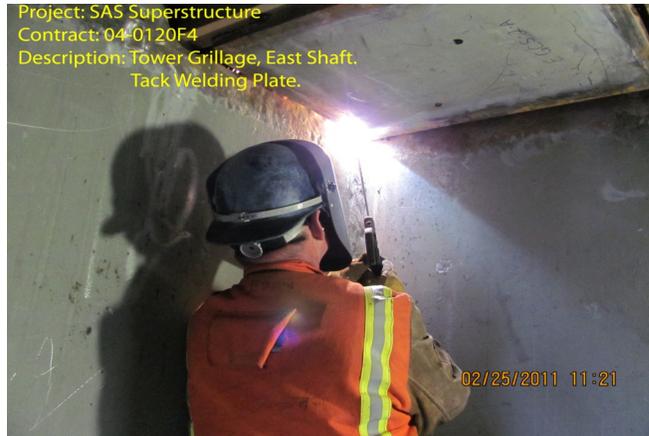
The QAI observed the installation and the assembly fit-up of the plates identified as P1, P5 and P7 located at the East and North shaft of the tower grillage. The fit-up and the tack welding operation was performed by Rick Clayborn, ID-2773 utilizing the Shielded Metal Arc Welding (SMAW) process to perform this task. The welding was performed in the overhead (4G) position with the work placed in an approximate vertical plane and the weld metal deposited from the underneath side of the weld joint. The minimum preheat temperature of 100 degrees Celsius and the interpass temperature of 230 degrees Celsius appeared to comply with the contract documents. The electrodes were stored in electrically heated, thermostatically controlled oven after removal from the sealed containers. The exposure limits of the 3.2 mm electrodes identified as E9018-H4R and the minimum storage oven temperature of 250 degrees Celsius appeared to be in compliance with the contract documents. At the time of the observation there were two (2) issues noted by the QAI (See Summary of Conversations). The fit-up of the plates appeared to comply with the contract documents.

The digital photographs on page 2 of this report illustrate some of the work observed during this scheduled shift.
