DEPARTMENT OF TRANSPORTATION

Quality Assurance and Source Inspection

Contract #: 04-0120F4Cty: SF/ALA Rte: 80 PM: 13.2/13.9File #: 99.28**WELDING INSPECTION REPORT****Resident Engineer:** Siegenthaler, Peter**Address:** 333 Burma Road**City:** Oakland, CA 94607**Report No:** WIR-021079**Date Inspected:** 27-Feb-2011**Project Name:** SAS Superstructure**OSM Arrival Time:** 700**Prime Contractor:** American Bridge/Fluor Enterprises, a JV**OSM Departure Time:** 1900**Contractor:** Zhenhua Port Machinery Company, Ltd (ZPMC) Chanxing Island**Location:** Shanghai, China

Bridge No: 34-0006**Component:** OBG Segment**Summary of Items Observed:**

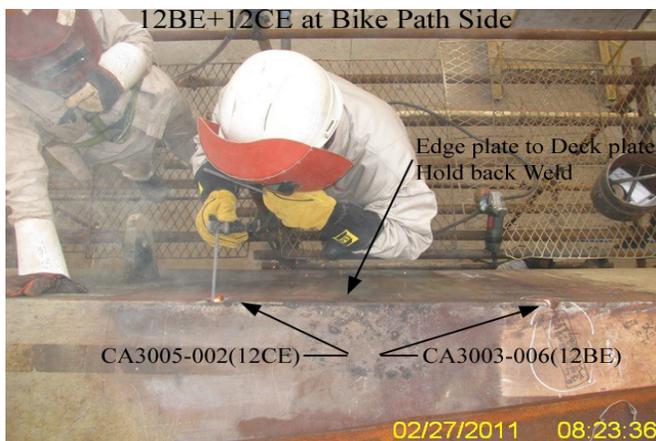
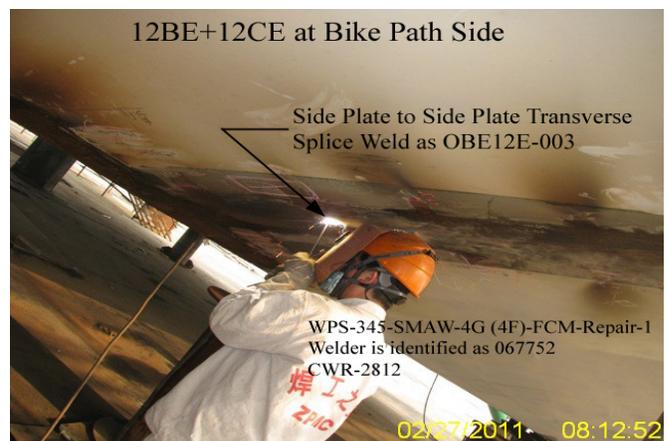
ZPMC welding personnel performing Shielded Metal Arc Welding of Repair weld for the edge plate to deck plate hold back weld joint located on 12BE+12CE at bike path side. The weld is designated as CA3003-006(12BE) & CA3005-002(12CE). The welder is identified as 040265. ZPMC QC Mr. WANG LI YANG was onsite monitoring the welding variables. The inprocess Shielded Metal Arc Welding appears to be progressing in compliance with WPS-345-SMAW-2G (2F)-FCM-Repair-1. The weld repair report number is named as CWR-2808.

ZPMC welding personnel performing Shielded Metal Arc Welding of Repair weld for the side plate to side plate transverse splice weld joint located on 12BE+12CE at bike path side. The weld is designated as OBE12E-003. The welder is identified as 067752. ZPMC QC Mr. WANG LI YANG was onsite monitoring the welding variables.

ZPMC welding personnel performing Shielded Metal Arc Welding of Repair weld for the bottom plate to side plate hold back weld joint located on 12BE+12CE at cross beam side. The weld is designated as SEG3003A-011. The welder is identified as 067752. ZPMC QC Mr. WANG LI YANG was onsite monitoring the welding variables. The inprocess Shielded Metal Arc Welding appears to be progressing in compliance with WPS-345-SMAW-4G (4F)-FCM-Repair-1. The weld repair report number is named as CWR-2815.

ZPMC welding personnel performing Shielded Metal Arc Welding of Repair weld for the edge plate to side plate hold back weld joint located on 12BE+12CE at bike path side. The weld is designated as CA3003-005. The welder is identified as 044502. ZPMC QC Mr. WANG LI YANG was onsite monitoring the welding variables. The inprocess Shielded Metal Arc Welding appears to be progressing in compliance with WPS-345-SMAW-4G (4F)-FCM-Repair-1. The weld repair report number is named as CWR-2809 R1.
