**DEPARTMENT OF TRANSPORTATION**

Quality Assurance and Source Inspection

**SEGMENT # 9W:**

# WELDING INSPECTION REPORT

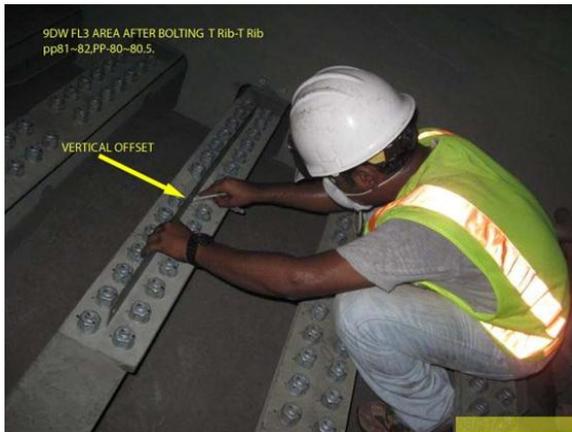
This QA Inspector along with Caltrans QA Mr. Manoj Prabhune performed Hand Measurement Survey Inspection for the T-Ribs to T-Ribs FL3 Vertical Offset, Panel Points(PP)-PP80~80.5, PP81~82.

Refernce as shown in photo below.
