Contract #: 04-0120F4Cty: SF/ALA Rte: 80 PM: 13.2/13.9File #: 69.28**WELDING INSPECTION REPORT****Resident Engineer:** Siegenthaler, Peter**Address:** 333 Burma Road**City:** Oakland, CA 94607**Report No:** WIR-021174**Date Inspected:** 19-Sep-2010**Project Name:** SAS Superstructure**OSM Arrival Time:** 700**Prime Contractor:** American Bridge/Fluor Enterprises, a JV**OSM Departure Time:** 1900**Contractor:** Zhenhua Port Machinery Company, Ltd (ZPMC), Changxing Island **Location:** Shanghai, China**CWI Name:** Tian Lei**CWI Present:** Yes No**Inspected CWI report:** Yes No N/A**Rod Oven in Use:** Yes No N/A**Electrode to specification:** Yes No N/A**Weld Procedures Followed:** Yes No N/A**Qualified Welders:** Yes No N/A**Verified Joint Fit-up:** Yes No N/A**Approved Drawings:** Yes No N/A**Approved WPS:** Yes No N/A**Delayed / Cancelled:** Yes No N/A**Bridge No:** 34-0006**Component:** OBG Segment Assembly**Summary of Items Observed:**

# WELDING INSPECTION REPORT

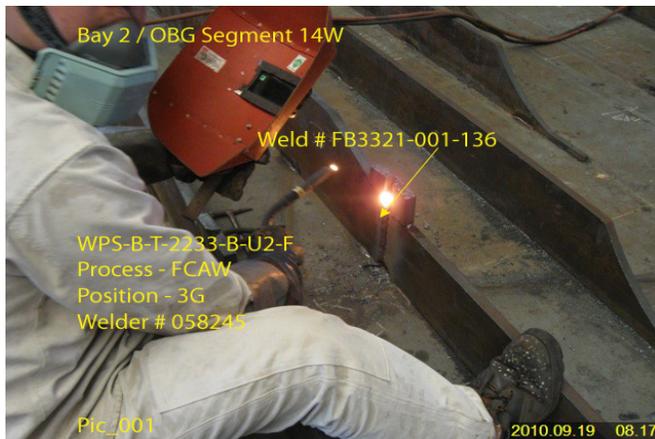
Bay 2 / OBG Segment 14W

Flux Core Arc Welding (FCAW) in the 3G position of Floor Beam 'I' rib splice weld # FB3321-001-136. The welder is identified as 058245. ZPMC Quality Control (QC) is identified as Zhu Lin. The welding variables recorded by QC appeared to comply with WPS-B-T-2233-B-U2-F. See attached photograph Pic\_001.

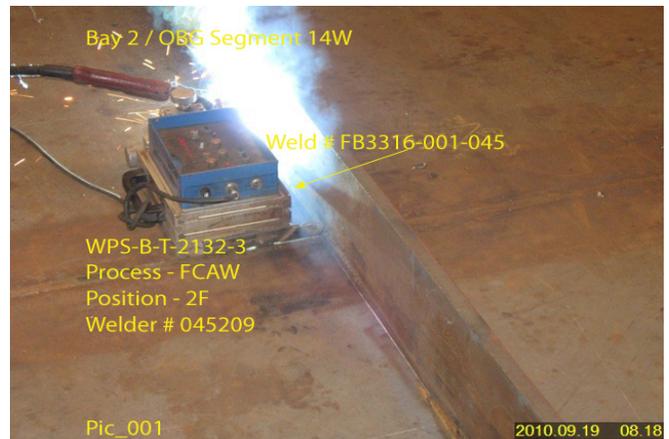
Bay 2 / OBG Segment 14W

Flux Core Arc Welding (FCAW) in the 2F position of Floor Beam to 'I' rib weld # FB3316-001-045. The welder

is identified as 045209. ZPMC Quality Control (QC) is identified as Zhu Lin. The welding variables recorded by QC appeared to comply with WPS-B-T-2132-3. See attached photograph Pic\_002.
