DEPARTMENT OF TRANSPORTATION

Quality Assurance and Source Inspection

Contract #: 04-0120F4Cty: SF/ALA Rte: 80 PM: 13.2/13.9File #: 69.28**WELDING INSPECTION REPORT****Resident Engineer:** Siegenthaler, Peter**Address:** 333 Burma Road**City:** Oakland, CA 94607**Report No:** WIR-021344**Date Inspected:** 26-Feb-2011**Project Name:** SAS Superstructure**OSM Arrival Time:** 700**Prime Contractor:** American Bridge/Fluor Enterprises, a JV**OSM Departure Time:** 1900**Contractor:** Zhenhua Port Machinery Company, Ltd (ZPMC), Changxing Island **Location:** Shanghai, China**CWI Name:** Geng Wei**CWI Present:** Yes No**Inspected CWI report:** Yes No N/A**Rod Oven in Use:** Yes No N/A**Electrode to specification:** Yes No N/A**Weld Procedures Followed:** Yes No N/A**Qualified Welders:** Yes No N/A**Verified Joint Fit-up:** Yes No N/A**Approved Drawings:** Yes No N/A**Approved WPS:** Yes No N/A**Delayed / Cancelled:** Yes No N/A**Bridge No:** 34-0006**Component:** OBG Components**Summary of Items Observed:**

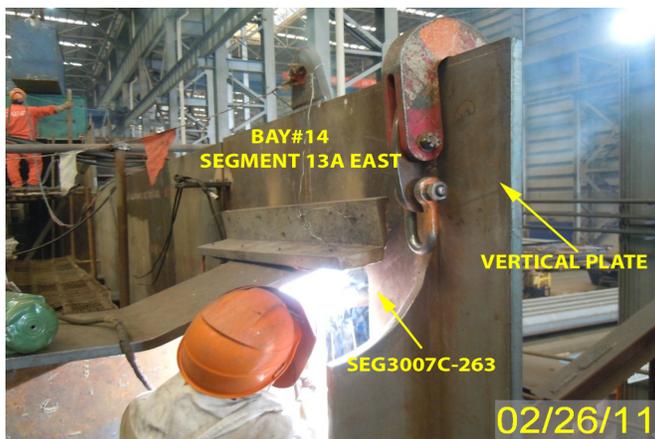
Weld joint #263 located on 13AE, SEG3007C. Welder is identified as 200113. ZPMC Quality Control (QC) Inspector is identified as Liu Hui Jie. The welding variables recorded by QC appeared to comply with the WPS-B-P-2214-Tc-U4b-FCM-1. (See attached photo)
